FIRE SAFETY AND ELECTRICAL SAFETY AUDIT OF RAM LAL ANAND COLLEGE- DELHI UNIVERSITY SOUTH CAMPUS

Conducted By: EM Project Services

Principal Auditor: Satvinder Singh

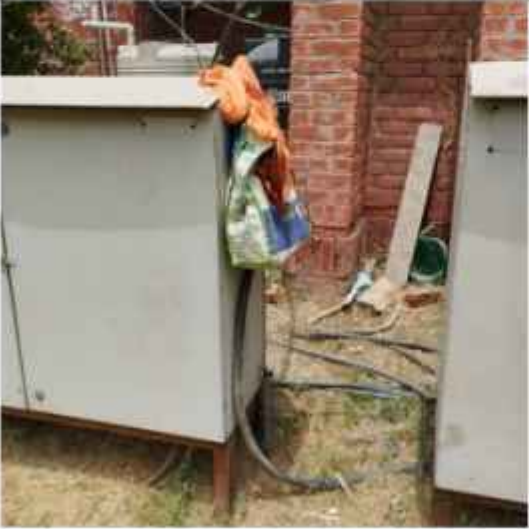
<p>Clothes hanging on LT panel- Cable laid Inappropriately- on ground without any sleeve.-Electrical Arc flash/Shock hazard</p>	<p>CEA-Regulations-2010</p>	<p>The complete electrical work up-to distribution boards are required to be re-done completely.</p>
2

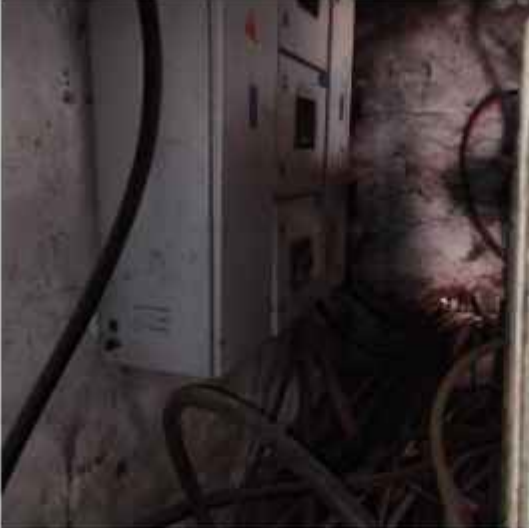
<p>Cables mess up no trench cover. No way to reach Power supply panel-Short Circuit-Arc Flash-Maintenance hazard-Can lead to Fire</p>	<p>CEA-Regulations-2010/ NFPA-70E</p>	<p>The complete electrical work up-to distribution boards are required to be re-done completely.</p>

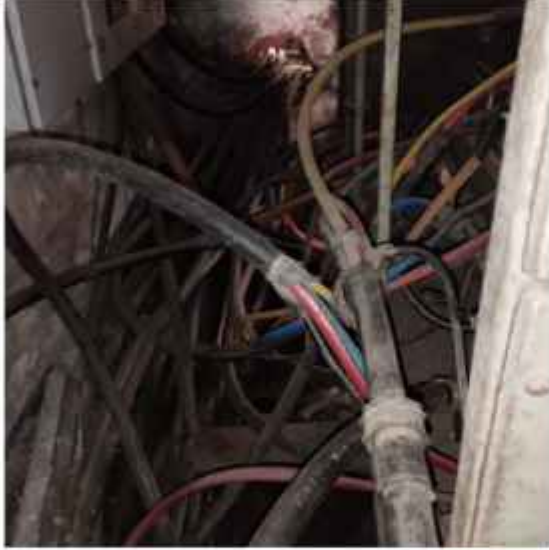
<p>Cables mess up no trench cover and no front or rear covers on LT panel- Short Circuit-Arc Flash-Maintenance hazard-Can lead to Fire-Earth discontinuity due to cable not terminated properly</p>	<p>CEA-Regulations-2010/NFPA-70E</p>	<p>The complete electrical work up-to distribution boards are required to be re-done completely.</p>
4

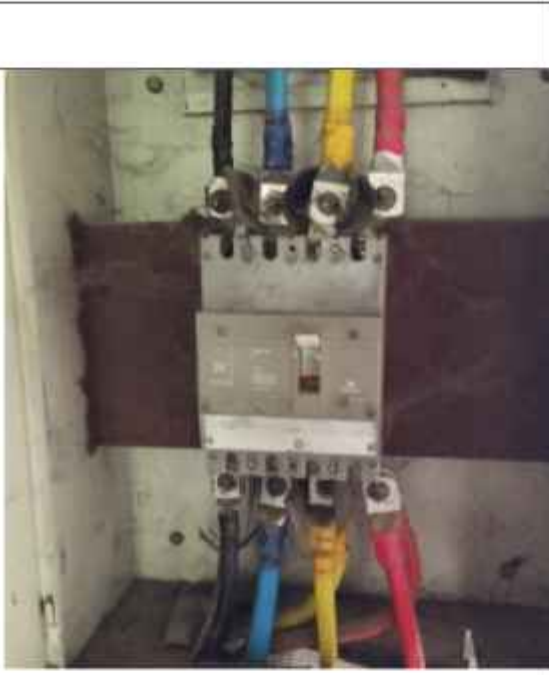
<p>Knock outs of cables not covered and no gland-Access to live parts-Arc flash hazard-Fire hazard-Web net seen-Maintenance issue</p>	<p>CEA-Regulations-2010/NFPA-70E</p>	<p>Proper cleaning practices should be followed after proper terminations and closing of all uncovered openings.</p>

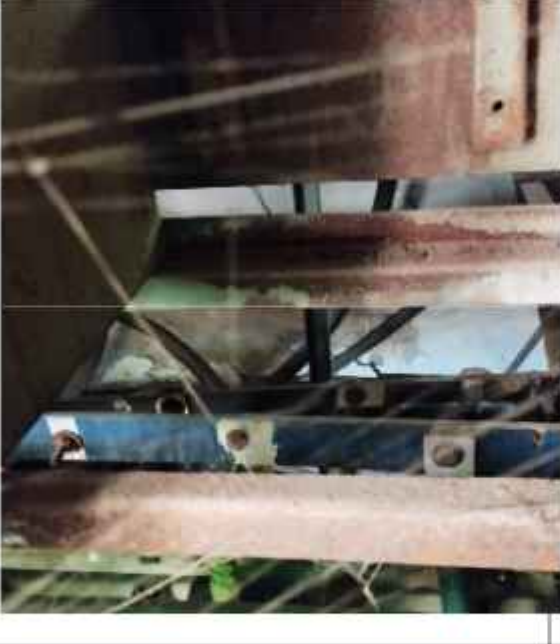
<p>Main LT Panels used as bus bar. Main cable directly terminated without any switch gear-No safety in case of any fault condition-will lead to fire</p>	<p>CEA-Regulations-2010/NFPA-70E</p>	<p>Proper designed system with complete wiring up to Distribution boards is recommended.</p>
6

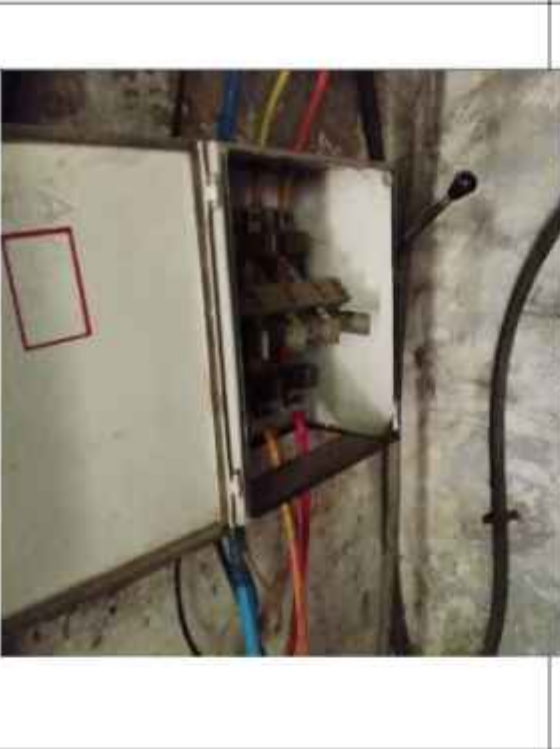
<p>Knock outs of cables not covered and no gland-Improper termination-Shock hazard-No cable end box provided for terminations.-Off load change over switch has been used.</p>	<p>CEA-Regulations-2010/NFPA-70E</p>	<p>Switch be replaced with On-Load switch with proper cable end box and end termination with brass compression glands.- Such similar issues to be repaired/treated in similar manner</p>

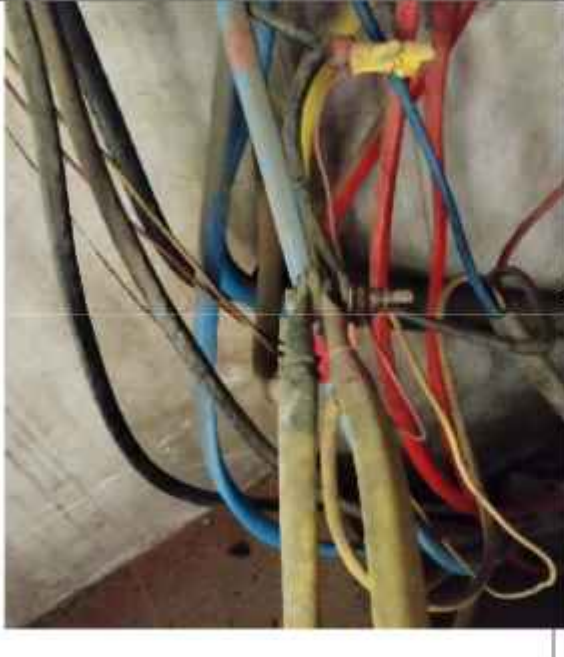
<p>Improper Open cable joint. Arc flash hazard. Proper designed system will replace unsafe conditions and jointing should be done at fixed terminals.</p>	<p>CEA-Regulations-2010/NFPA-70E</p>	<p>Should be replaced in designed system</p>
8

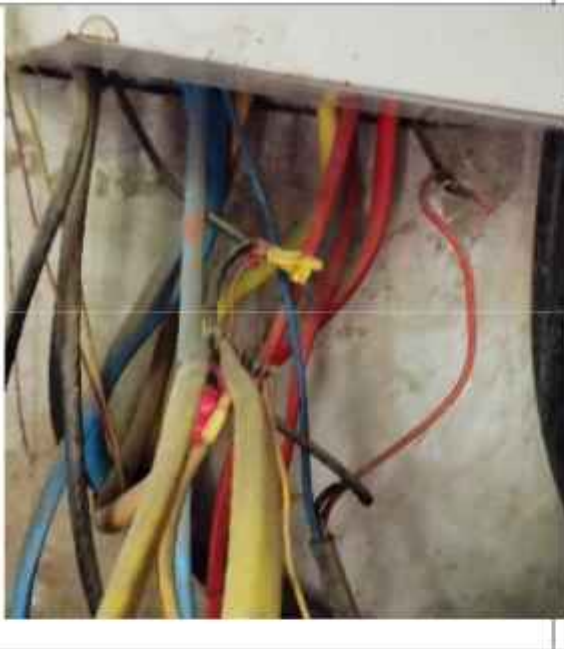
<p>Improper Open cable joint without any insulation.</p>	<p>CEA-Regulations-2010/NFPA-70E</p>	<p>Should be replaced in designed system</p>

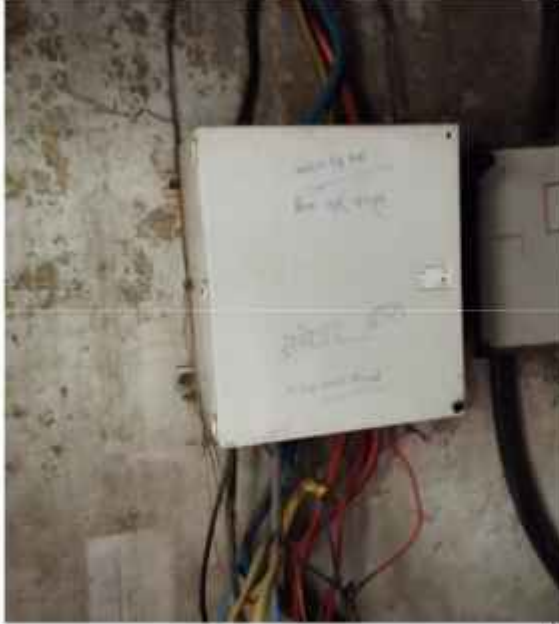
Change over – no gland and knock out plate	CEA-Regulations-2010/NFPA-70E	Switch be replaced with On-Load switch with proper cable end box and end termination with brass compression glands.- Such similar issues to be repaired/treated in similar manner
10

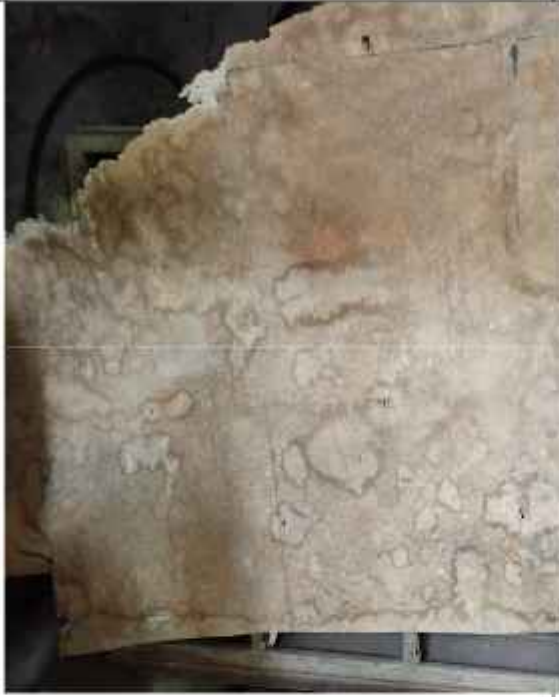
Main LT Panel covered with sheet. No front or rear doors-Arc flash hazard-can lead to fire	CEA – Guidelines-2010/NFPA-70E	LT panel To be replaced with complete wiring

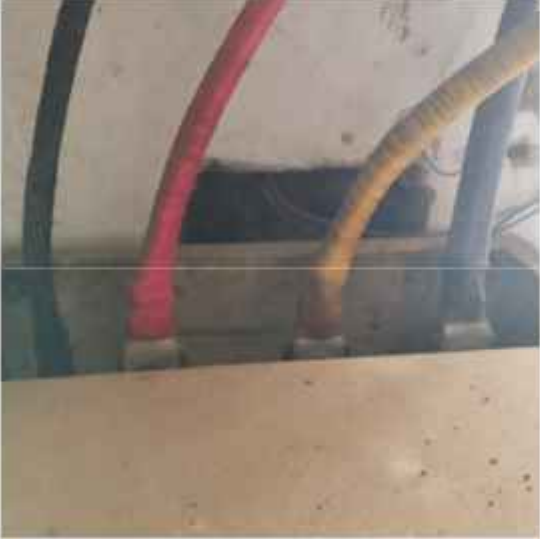
<p>Knock outs of cables not covered and no gland-Arc flash hazard-can lead to electrocution and fire-Also cable end box not provided for termination.</p>	<p>NFPA-70E/CEA Guidelines</p>	<p>To be provided.</p>
12

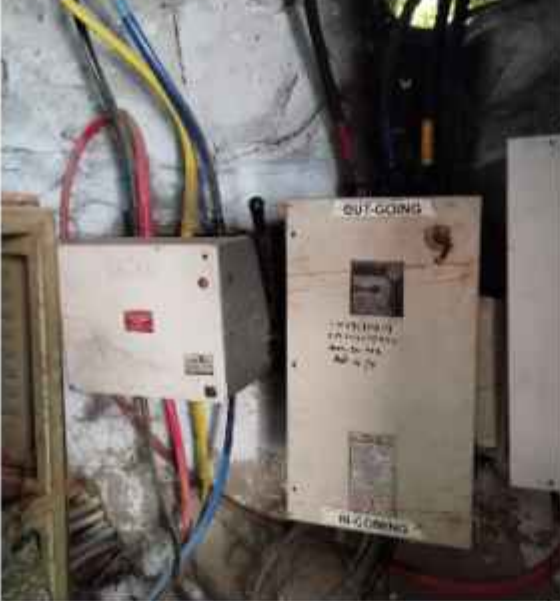
<p>Cables mess up no proper dressing and termination</p>	<p>NFPA-70E/CEA Guidelines</p>	<p>To be provided.</p>

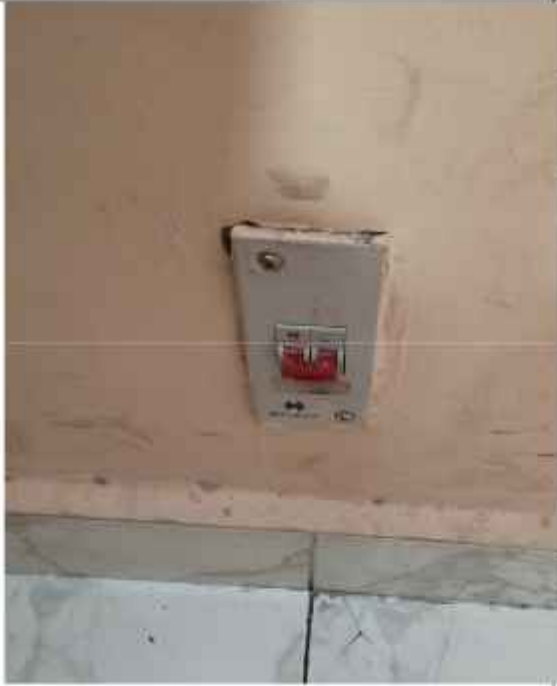
Isolator in place of MCB for AC- Non tripping device –Can lead to unsafe conditions.	CEA guidelines-2010

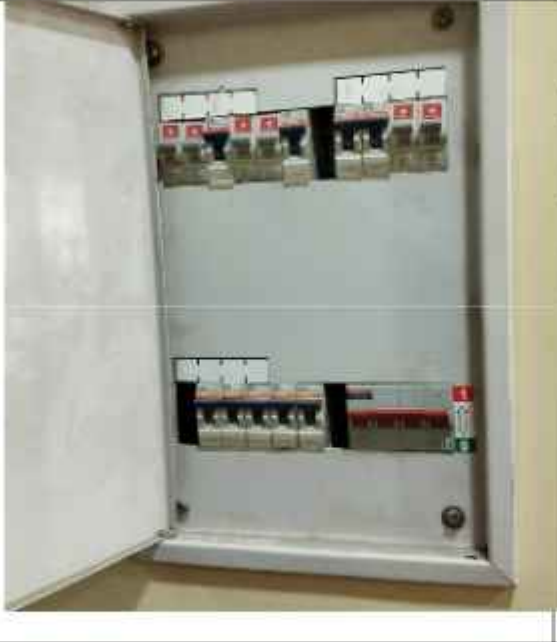
<p>Isolator in place of MCB and no blanking plates- live parts exposed-Non tripping device used. Different make MCB's used</p>	<p>CEA guidelines- 2010</p>	<p>All isolators should be replaced with MCB and blanking plates be provided at all locations.</p>
16

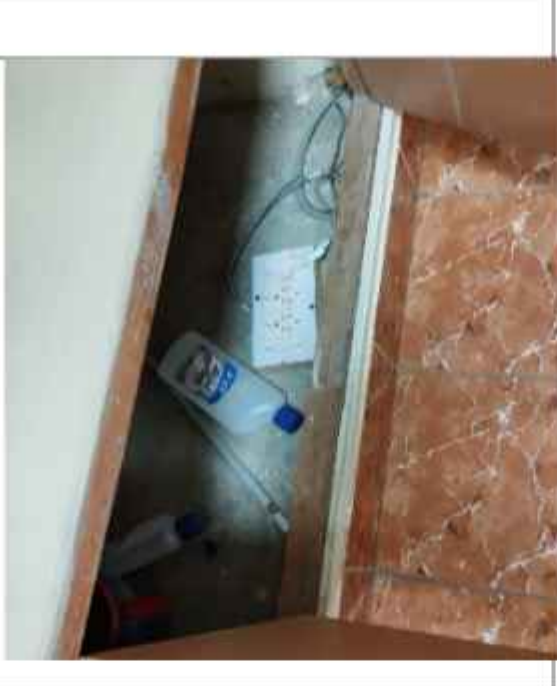
<p>Extension box connected inside wooden cabinet- Fire hazard</p>	<p>CEA regulations- 2010</p>	<p>Such practices should be not followed and discontinued immediately</p>

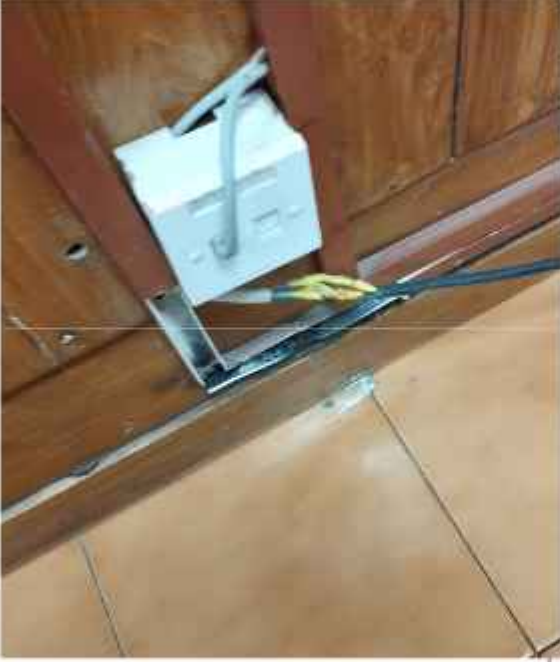
Wire laying without any conduit-Jointing seen-fire hazard	CPWD specifications	Jointing of wires should be avoided and wires should always be laid inside conduit
18

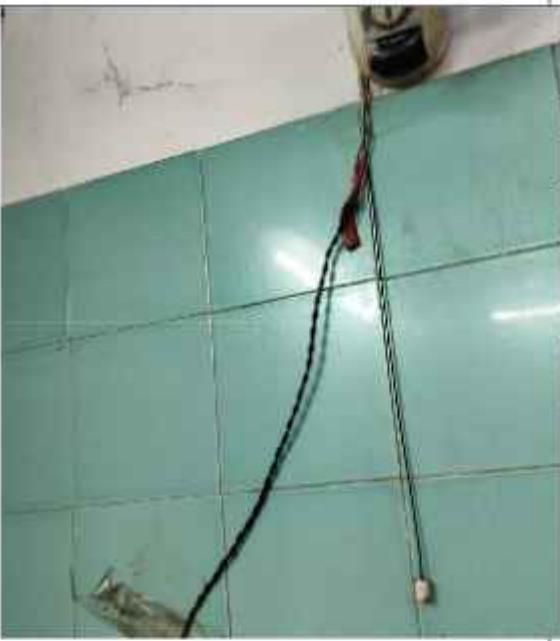
Exhaust fan connected without any earth wire in canteen-Also wires used is flexible and is not as per requirement-Jointing is noticed-Unsafe condition	IS-3043/CPWD specifications	Such practices should be discontinued.

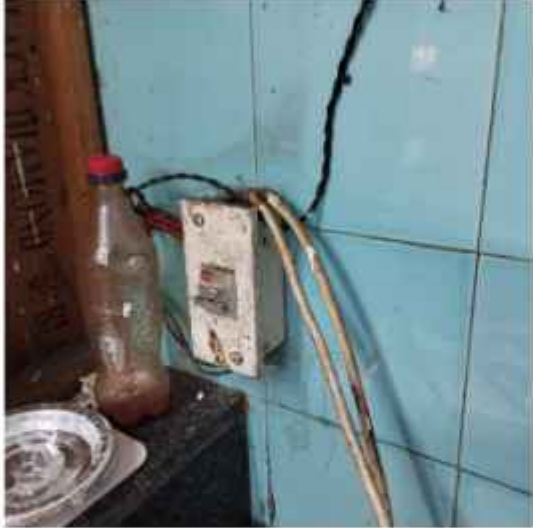
<p>DP MCB connections in canteen- Improper connections in dangerous area where LPG is used-Fire hazard.</p>	CEA guidelines	<p>Proper wiring as per requirement should be done and in future also repair should be done in proper manner.</p>
20

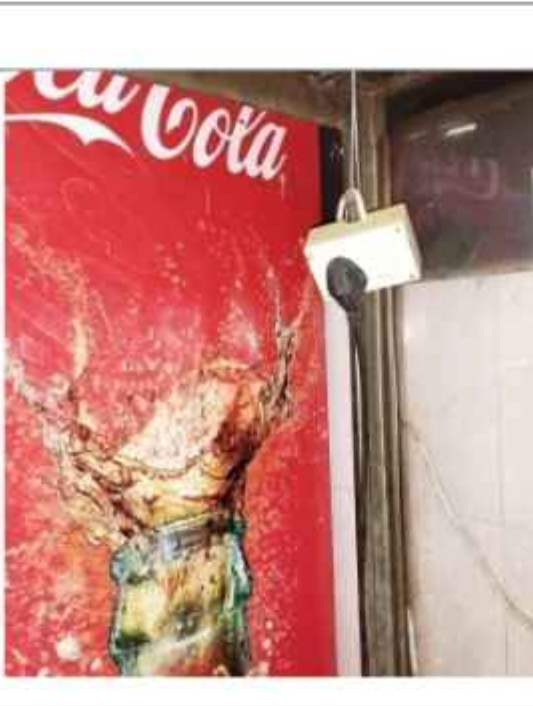
<p>Switch box hanging at canteen for refrigerator- Shock hazard</p>	CPWD specifications/CEA guidelines	<p>Only permanent points should be provided for tapping of electricity</p>

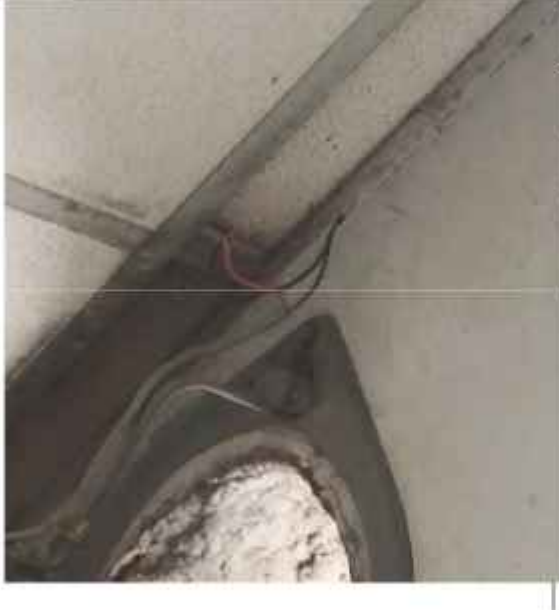
Exhaust fan wire joint without any PVC insulated tape-Shock and spark –Fire hazard	CEA guidelines-2010	This type of work should not be done. Proper wire with earth connection should be tapped from ceiling rose.
22

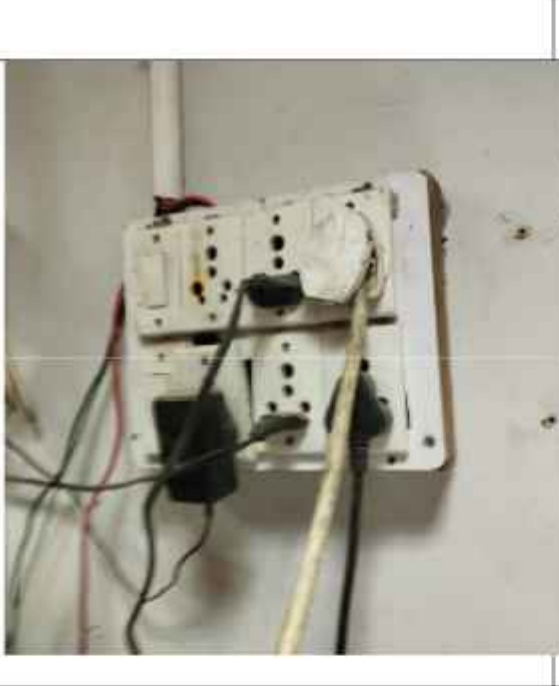
Switch board in canteen without earth wire-Shock and accident hazard	IS-3043/CPWD specifications	Earth connection should be provided and the multi sockets should not be permitted from single circuit to eliminate chance of over loading.

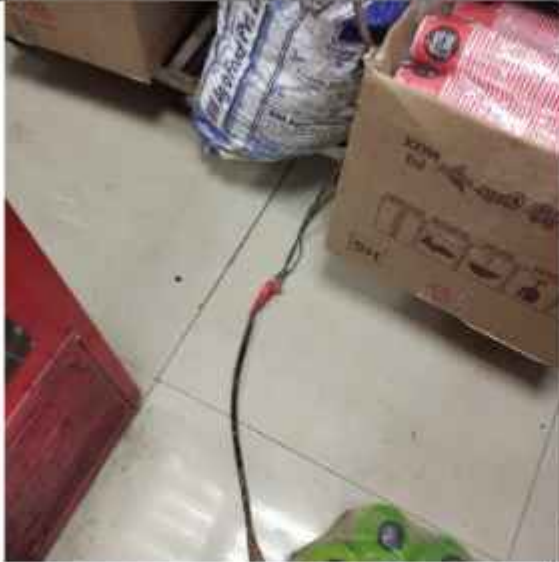
Wire laying on ground in passage in canteen-Shock and fire hazard	CPWD specifications/CEA guidelines-2010	Sufficient number of outlets as per requirement should be provided with design wiring.
24

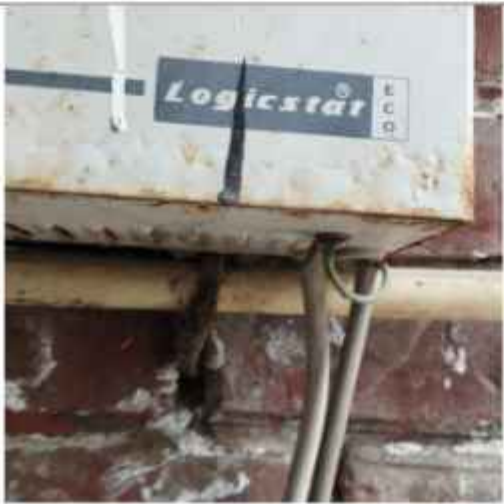
No earthing provided-Shock hazard	IS-3043	All metallic parts –non current carrying are required to be provided with earth connection.

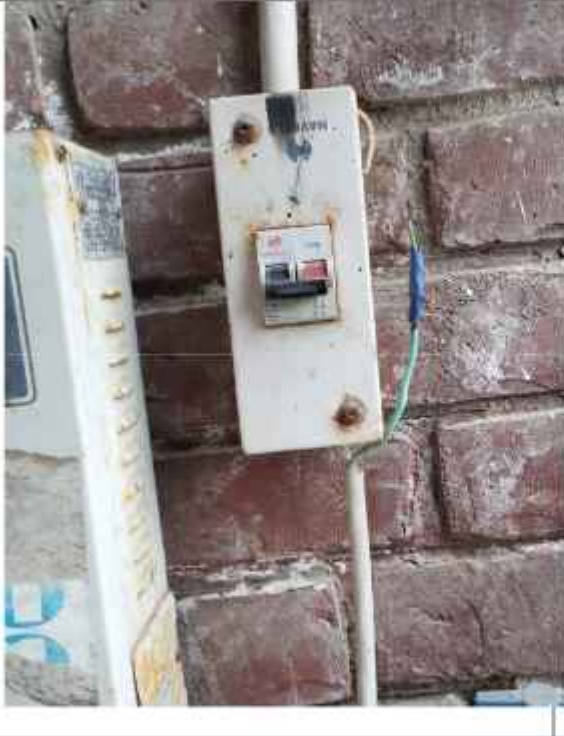
Earth wire not connected	IS-3043	All metallic parts –non current carrying are required to be provided with earth connection.
26

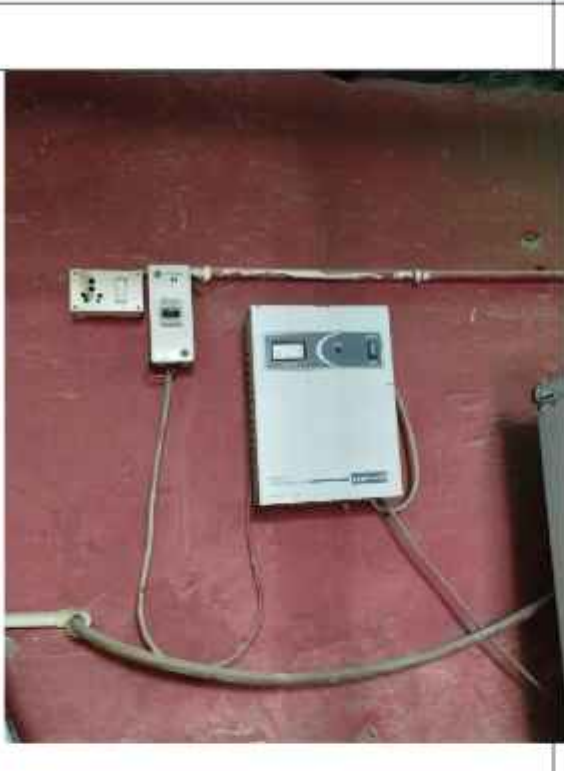
Earth wire not connected	IS-3043	All metallic parts –non current carrying are required to be provided with earth connection.

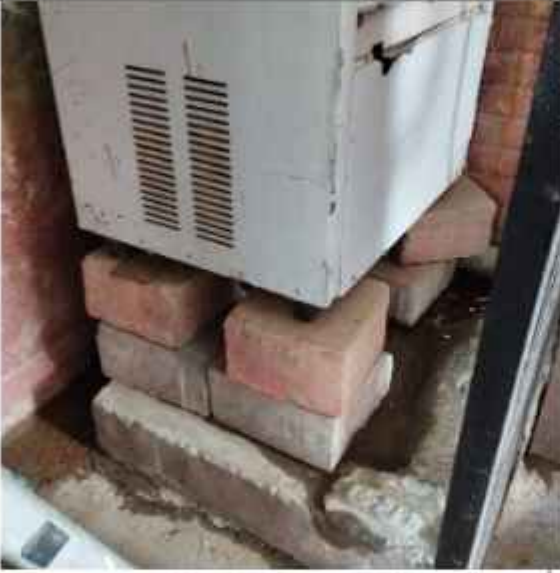
Water cooler fixed on stone bricks-Accident hazard	Best practices	Electrical equipment should be installed on firm foundations
28

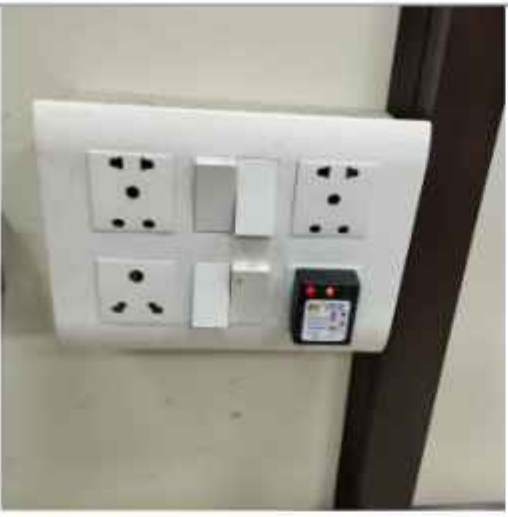
Reversed polarity

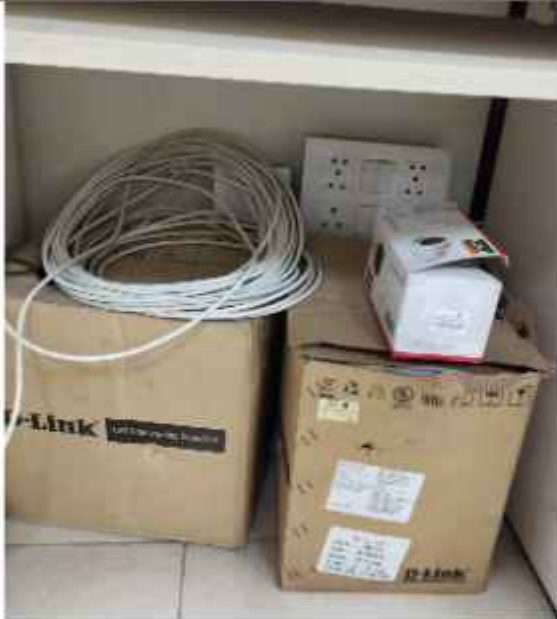
Inflammable Material stacking in front of switch board-Fire hazard	CPWD specification s	No inflammable material should be placed in vicinity of electrical plug points.
30

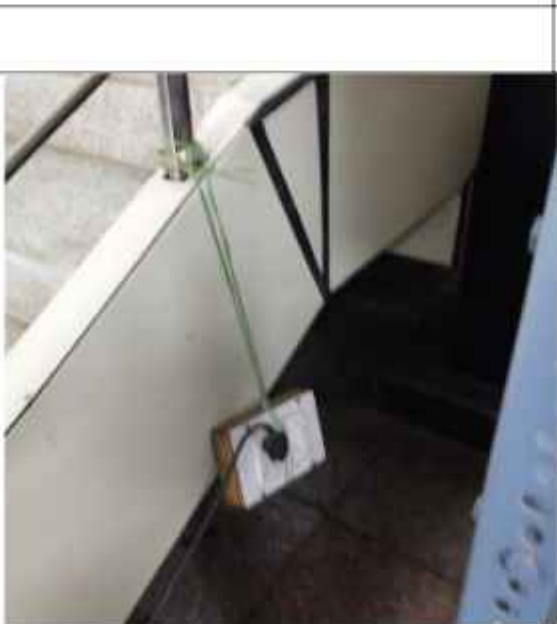
Switch board hanged in library with high fire load	CPWD specification s	No loose electrical points should be installed and all such points be permanently fixed as per requirement .

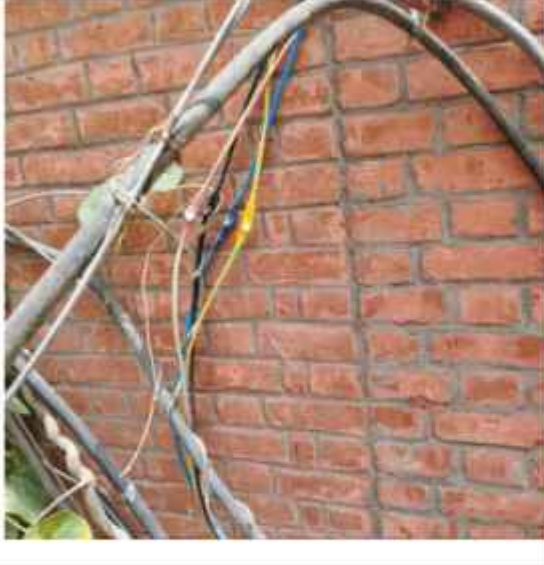
Laying of cables out going from front side LT Panels-Practice of requirement of providing mechanical protection is not followed.	CEA guidelines-2010/CPWD specifications	To be corrected with new wiring
32

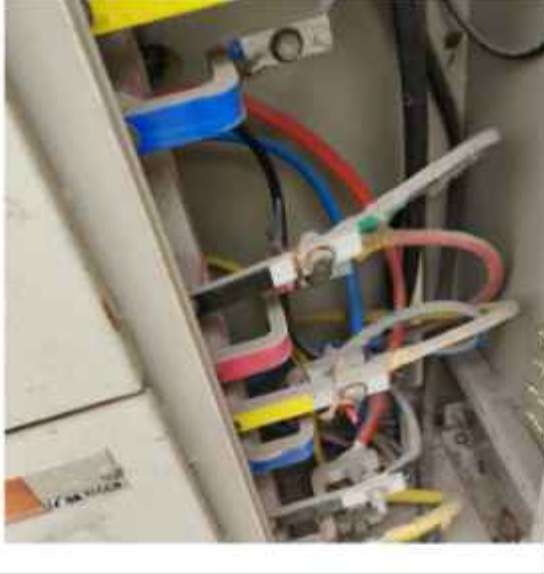
Cables connected without thimbles-Loose connection and Arc flash hazard.	CPWD specifications	All terminations should be done with thimbles.

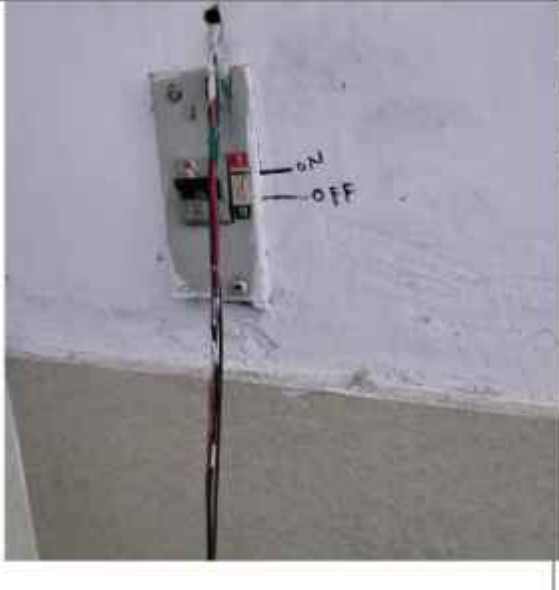
Wires passing through wall without conduit pipe- Unsafe practice	CPWD specifications	Should be laid following CPWD specifications. be laid as per
34

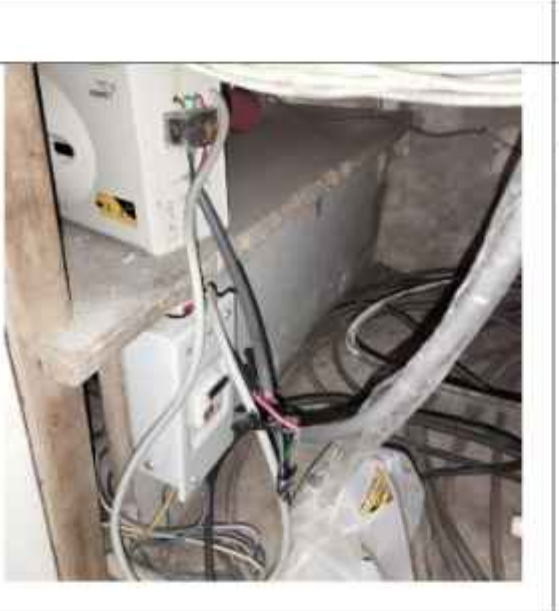
MCB box and UPS in covered wooden cabinet- Fire Hazard	CPWD specifications	Electrical switch gear should not be enclosed with flammable material
35

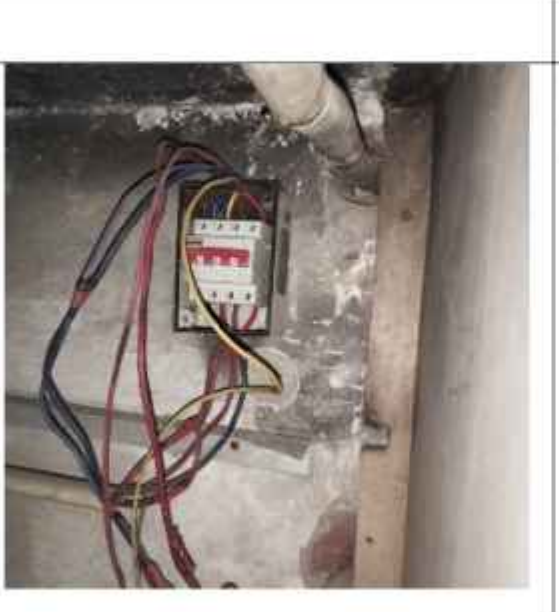
MCB box in covered wooden cabinet	CPWD specifications	Electrical switch gear should not be enclosed with flammable material

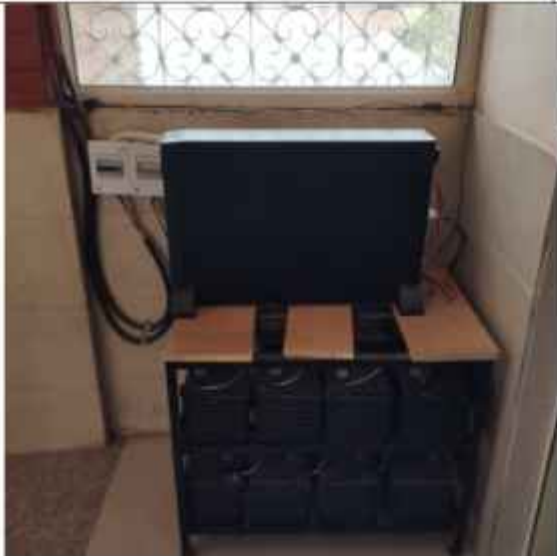
Batteries of UPS stacked inside the room-NO ventilation	CEA Regulations- 2010	Batteries room should be provided with adequate ventilation

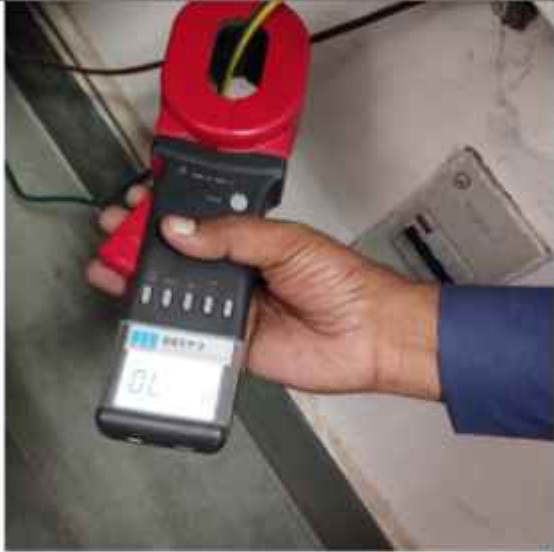
Computer room earth-Not seen connected-Shock hazard	IS-3043	Earth should be provided.
39

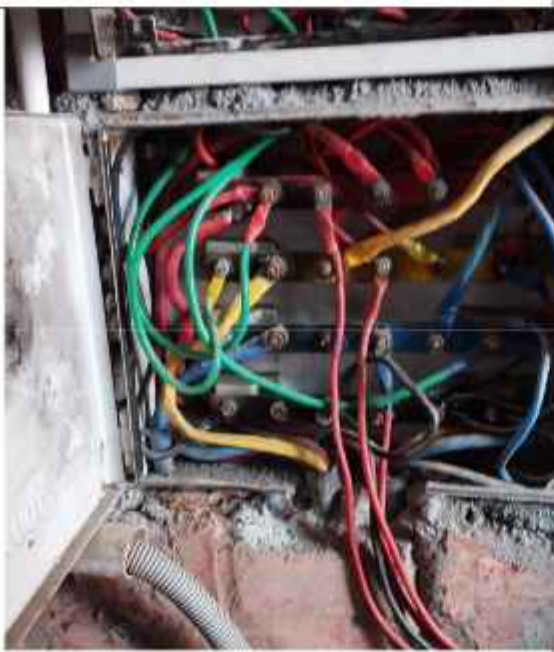
Wires entering in bus bar near old Auditorium-Arc flash-Shock and fire hazard	CPWD specifications/CEA guidelines-2010	Properly designed electrical system should be provided.

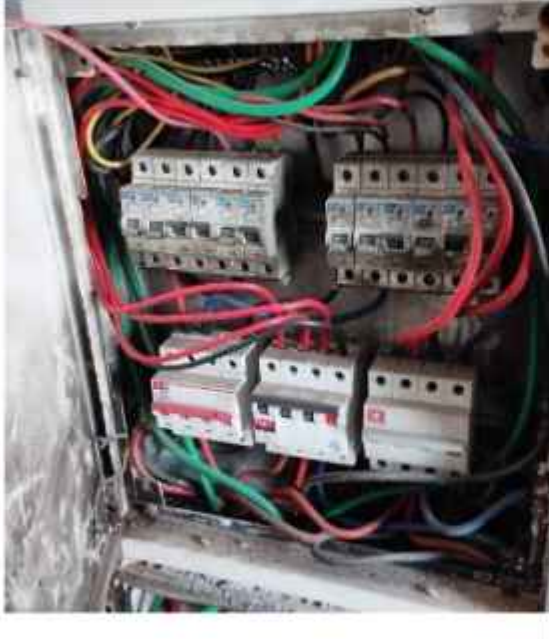
Wiring in MCB DB near old Auditorium	CPWD specifications/CEA guidelines-2010	Properly designed electrical system should be provided.
41

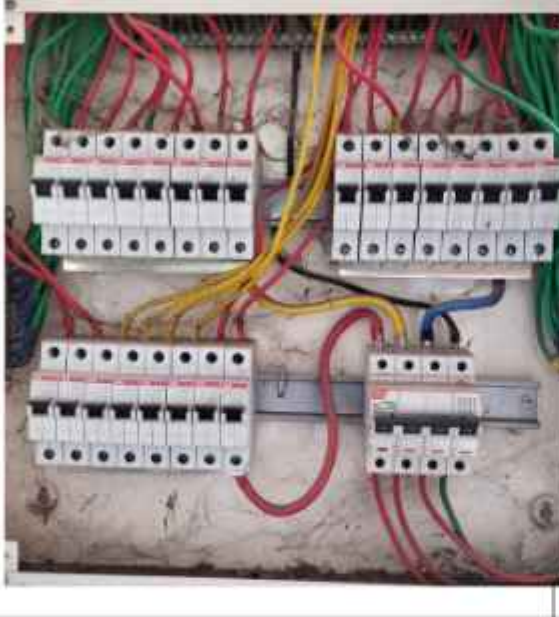
All outgoing earth wires connected but no earth with incoming cable- Shock hazard	IS-3043	These should be provided as per requirement of two distinct earth connections in case of three phase supply.
43

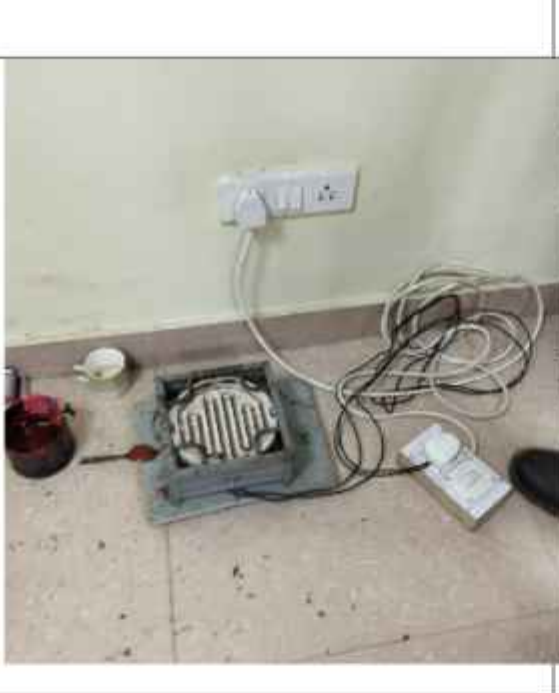
Extension board connected with heater at committee room- No earth -Heater is used without earth connection- Arc flash, shock and and fire hazard.	IS-3043/CPWD guidelines/CEA regulations -2010	This is a very serious fire hazard and practice of using extension boards should be stopped

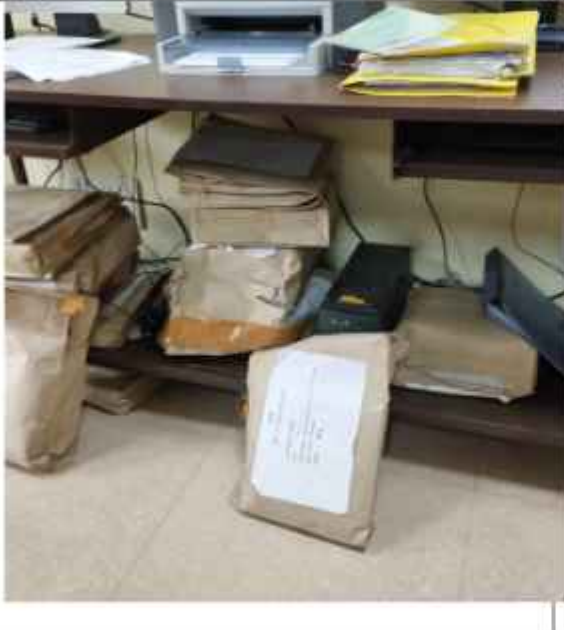
Material stacked in front of switch boards at committee room- Fire hazard.	CPWD specifications	The practice should be discontinued.
45

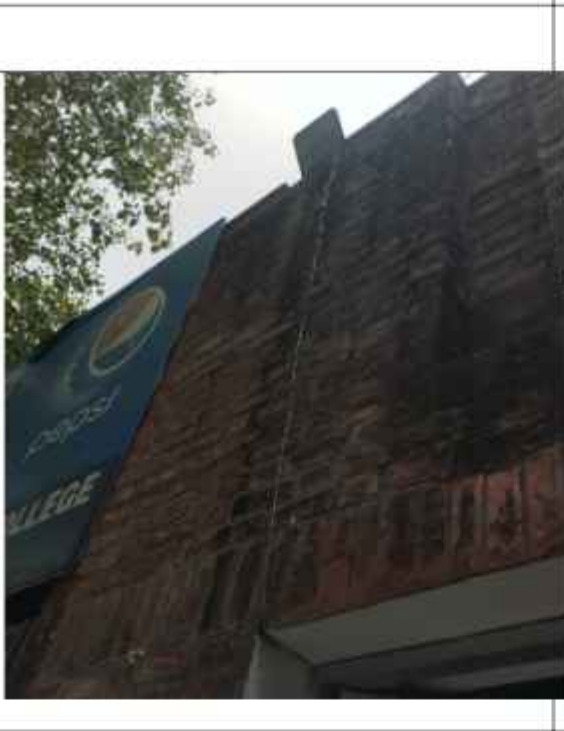
Fittings on walls not earthed- Shock hazard. Temporary connections provided.	IS-3043	Earth connection should be provided and temporary wiring should be avoided for safe conditions.

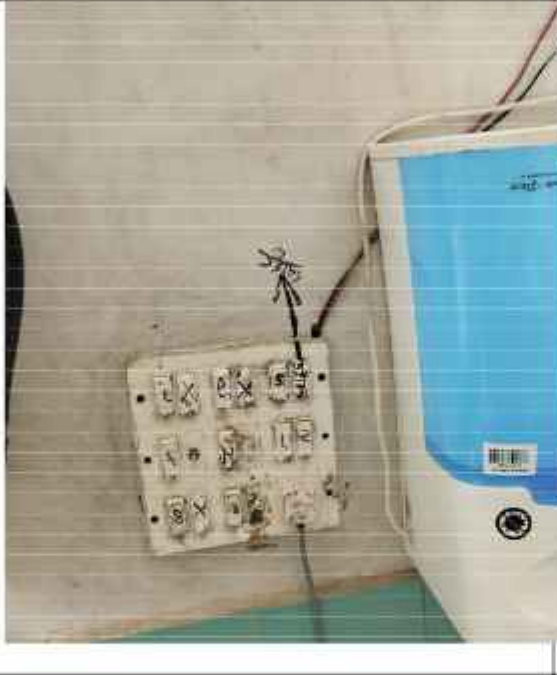
Two wires openly connected with exhaust fan-Earth not provided	IS-3043/CEA regulations-2010	Such practices should be immediately stopped.
47

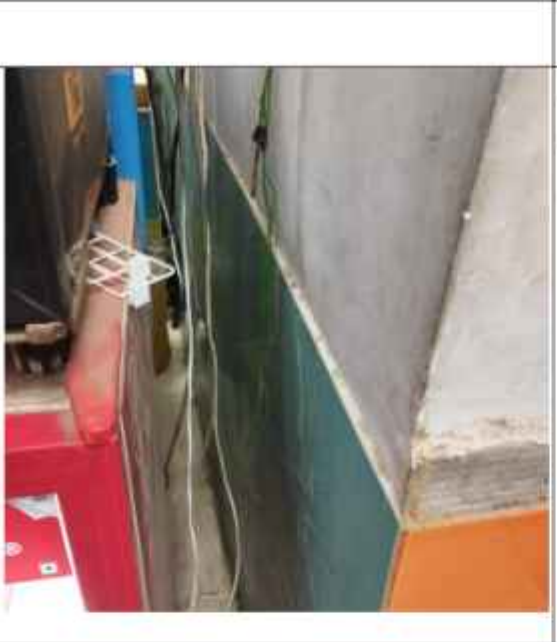
Hanging wires in kitchen- in area where LPG is used.	CPWD specifications	Complete wiring of kitchen should be re-done.

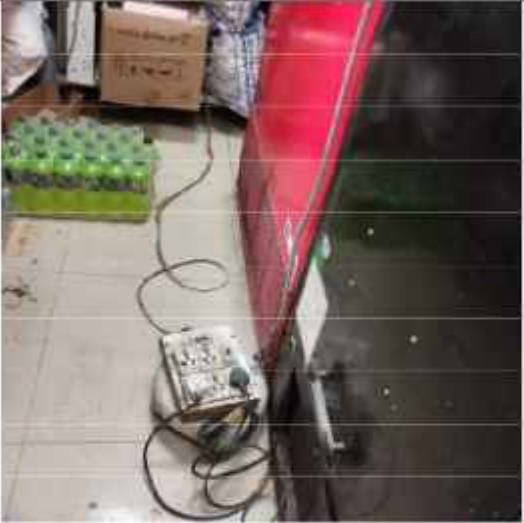
<p>Extension switch boards wire laid on ground in kitchen- Electrocution and Fire hazard</p>	<p>CPWD specifications</p>	<p>Complete wiring of kitchen should be re-done.</p>
49

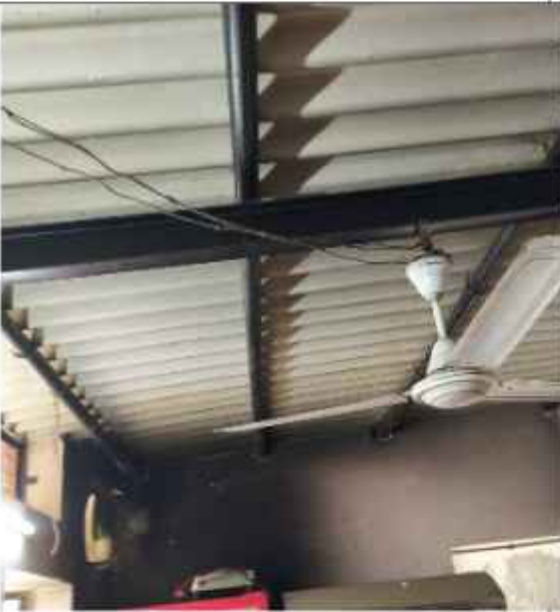
<p>Ceiling fan hanged on MS pipe without earth wire and open wiring- Temporary wiring -Charging of MS structure with leakage current can cause major accident.</p>	<p>IS-3043/CEA regulations-2010</p>	<p>Such practices can lead to serious accidents.</p>

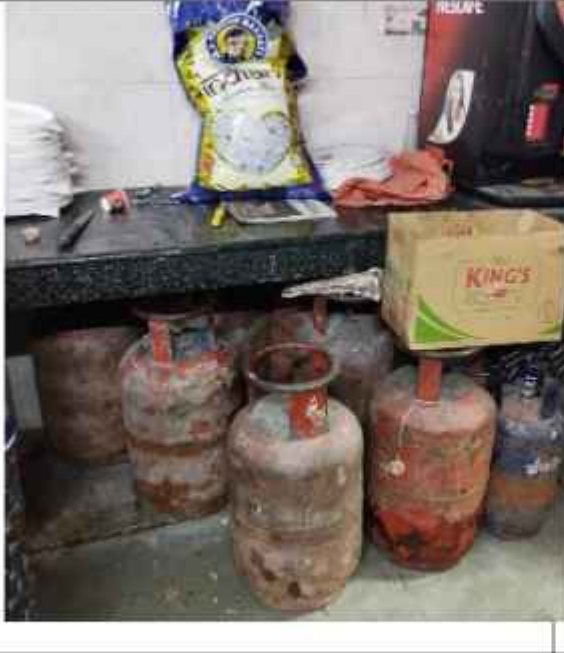
Empty LPG cylinders stacking inside kitchen- Fire hazard	Fire guidelines	These should be kept in an enclosure
51

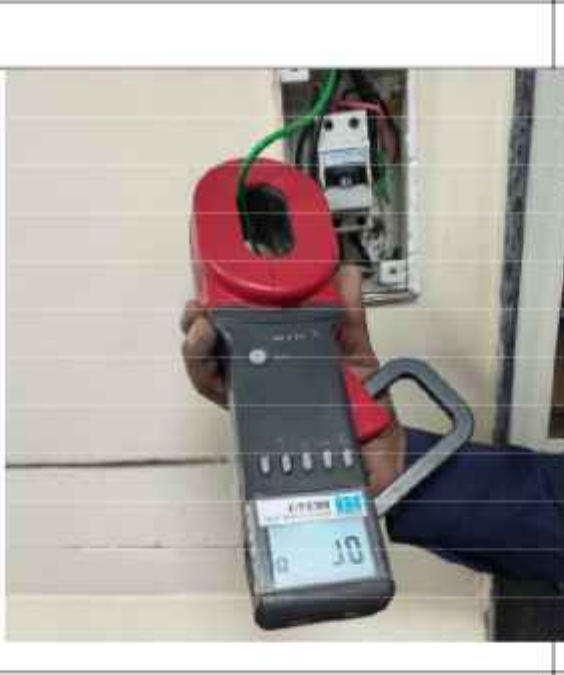
No earth in library AC outgoing-Shock hazard	IS-3043	Earth connection should be provided.

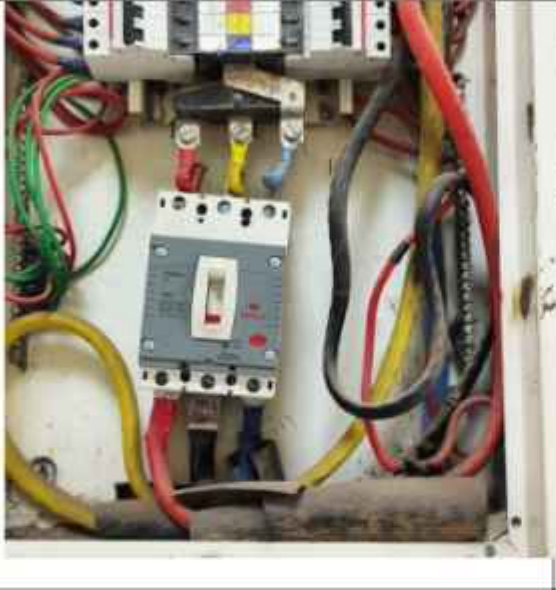
Main incoming lighting MCCB in Library – no earth and no proper termination	IS-3043	Earth connection should be provided. Proper terminations should be done
53

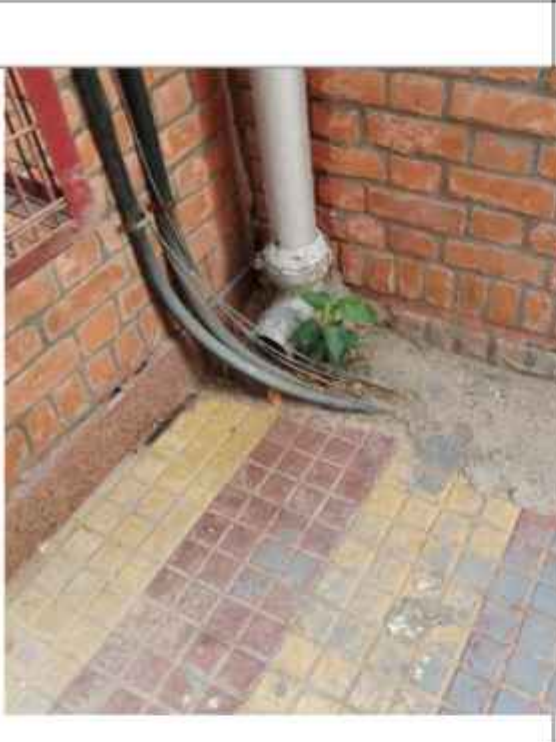
Cables directly in hard ground- Improper laying practice-Cables up to 1.8 metres in vertical should be mechanically protected	CEA guidelines/C PWD specifications	Proper specifications for cable laying should be followed.

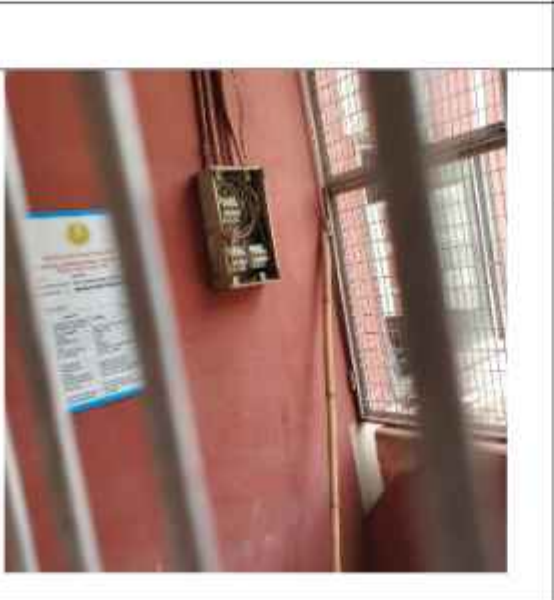
MCBDB near Solar meter without cover-Arc flash hazard	NFPA-70 E	Access to live opening should not be existing
56

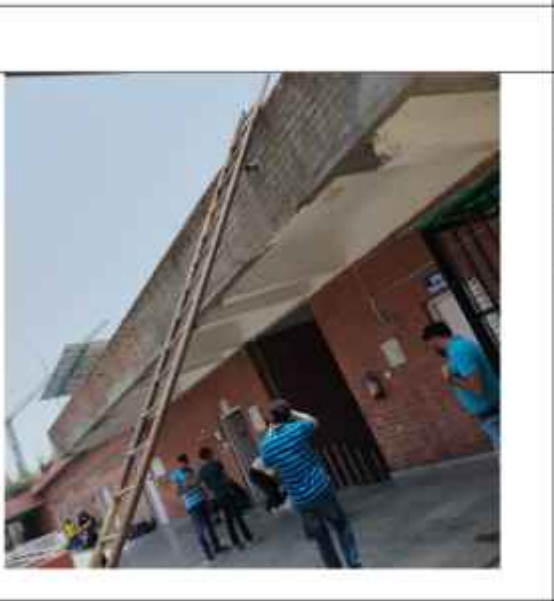
Ladder for second floor at Academic block-Not provided with railing-Fall hazard	IS-14489	Railing should be provided.

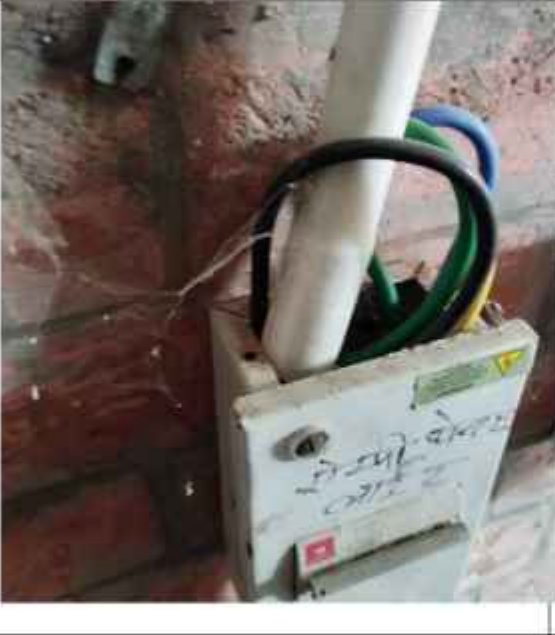
Cable termination-hazardous-exposure of live parts	CEA guidelines	Need to be terminated as per requirement .
58

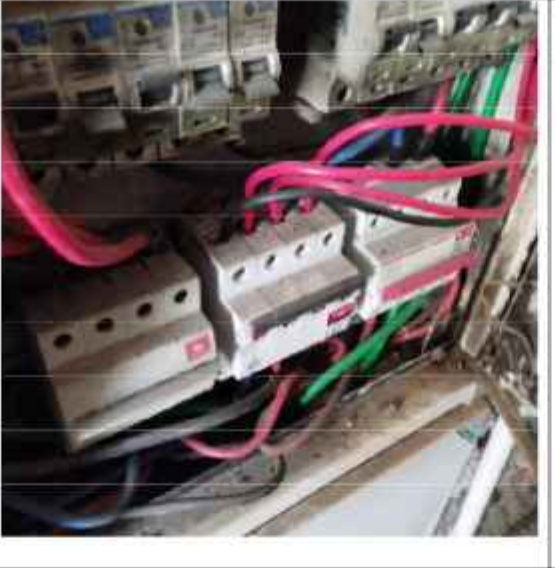
Termination without thimbles

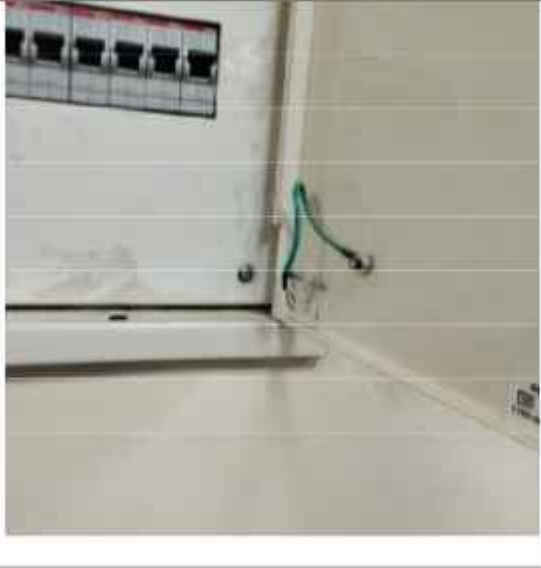
Earth wire not connected-shock hazard	IS-3043	Earth be connected
60

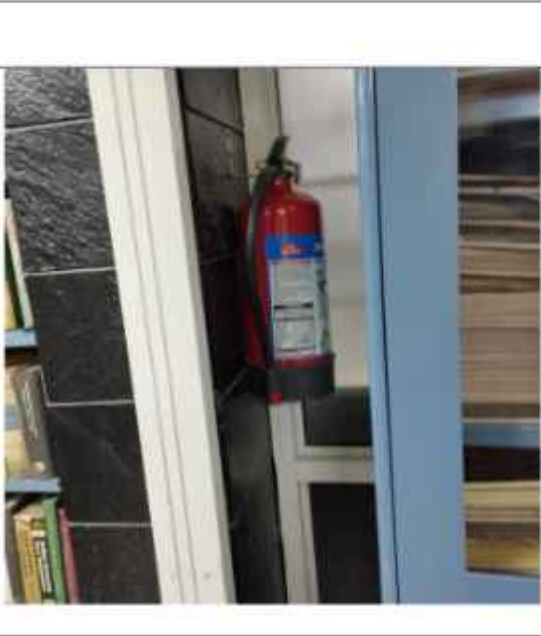
Fire extinguisher – in library-not accessible	IS-2190	Fire extinguisher should not be accessible
61

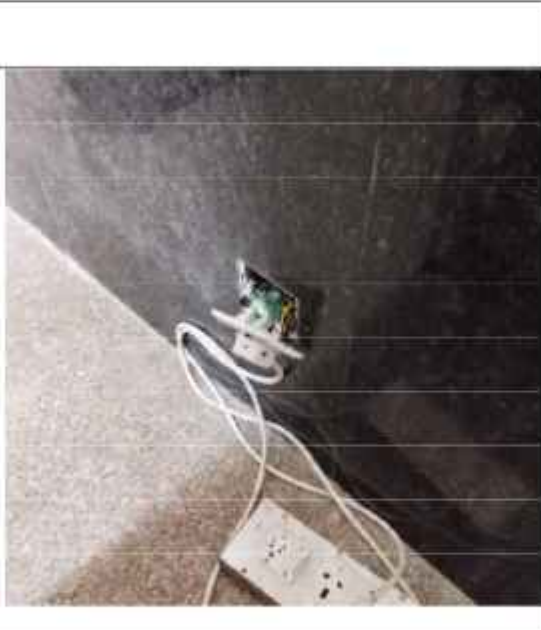
Sheet hanging in library-Fire hazard	CEA regulations-2010	This should be corrected and all installation should be maintained at all times

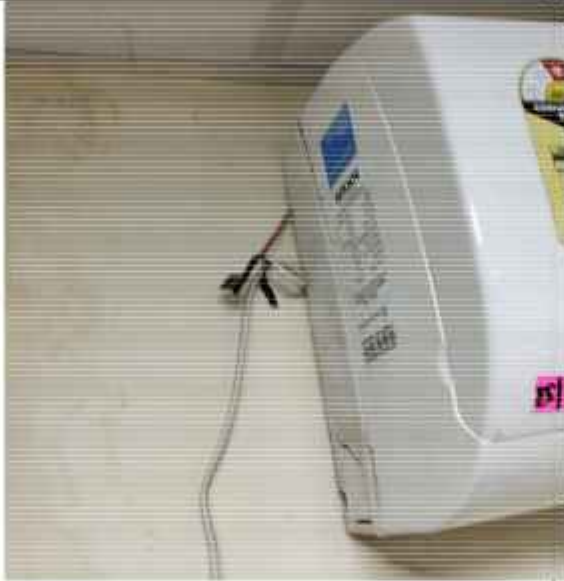
<p>Ac wire connection and no earth wire- Improper AC connections can lead to fire-Shock and fire hazard</p>	<p>IS-3043/CEA guidelines-2010</p>	<p>To avert incident of fire at all air conditioners such practices should be avoided.</p>
63
