FIRE SAFETY AND ELECTRICAL SAFETY AUDIT OF RAM LAL ANAND COLLEGE- DELHI UNIVERSITY SOUTH CAMPUS

Conducted By: EM Project Services

Principal Auditor: Satvinder Singh

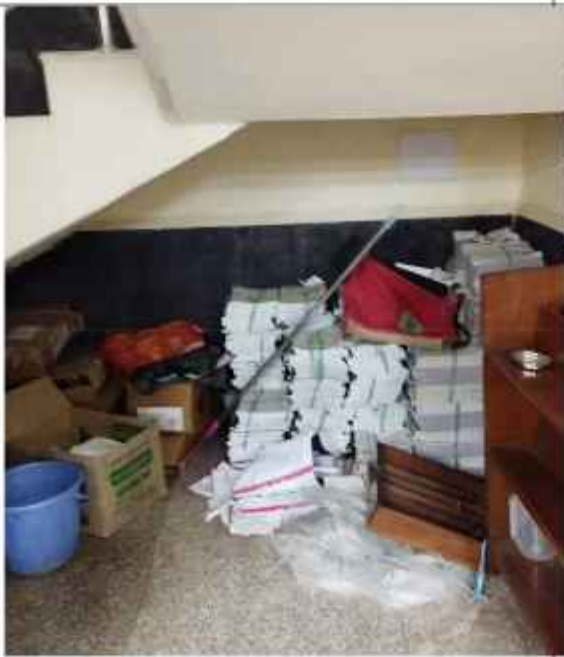
<p>Material stacked in library under stair case- Improper housekeeping practices-Fire hazard.</p>	<p>CPWD specifications/Best practices</p>	<p>The material should be properly stacked to avert incident of fire.</p>

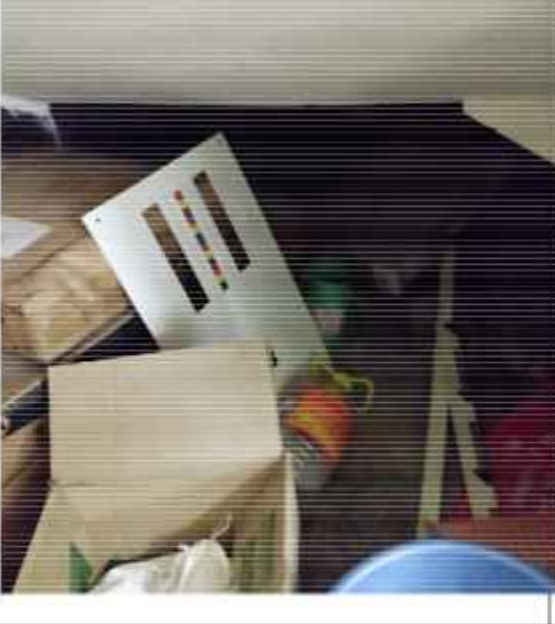
Material stacked in library under stair case- Improper housekeeping practices- Fire hazard.	CPWD specifications/Best practices	The material should be properly stacked to avert incident of fire.
65

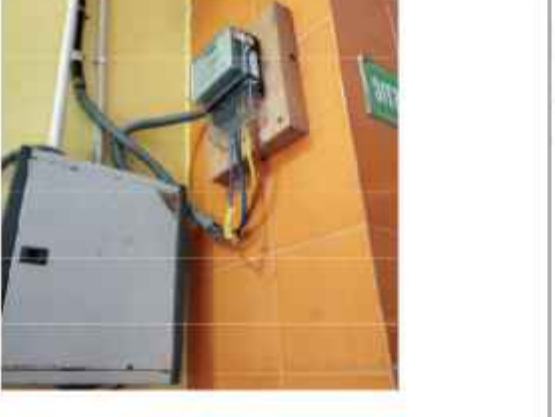
Main incoming at canteen- without earth wire- Shock hazard	IS-3043	Earth should be provided.

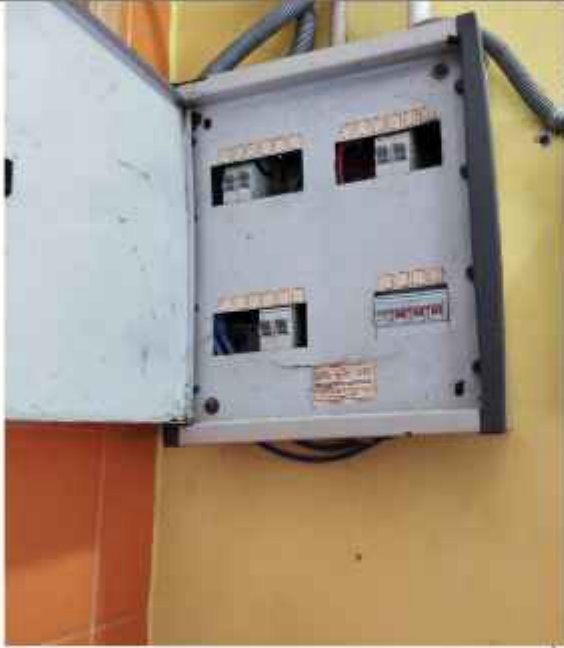
No blanking plates-access to live parts-Arc flash hazard	CEA guidelines/NFPA-70E	All uncovered opening should be covered with blanking plates.
67

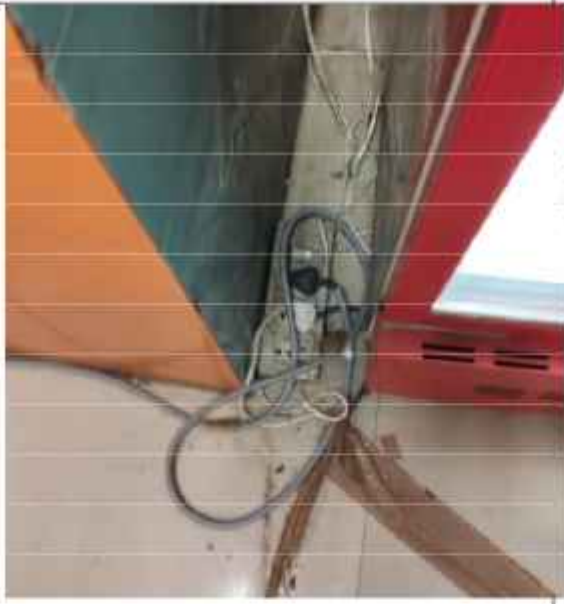
Wires laid on ground at canteen-Shock and Arc Flash hazard-Can cause fire	CEA guidelines-2010/CPWD specifications	All electrical sockets should be fixed at wall for electrically safe condition

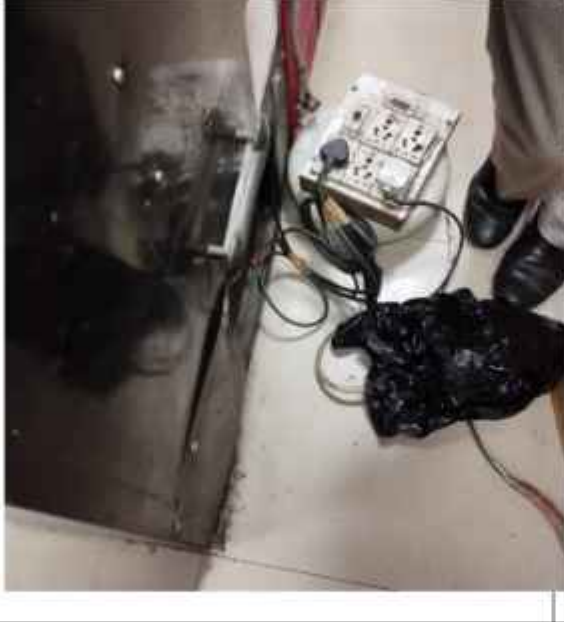
Wires laid on ground at canteen- Shock and Arc Flash hazard-Can cause fire	CEA guidelines-2010/CPWD specifications	All electrical sockets should be fixed at wall for electrically safe condition
69

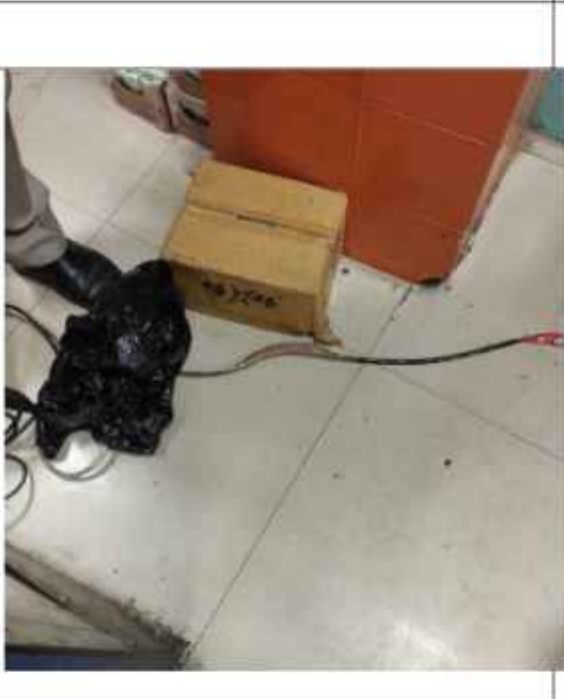
Wires laid on ground at canteen	CEA guidelines-2010/CPWD specifications	All electrical sockets should be fixed at wall for electrically safe condition
