FIRE SAFETY AND ELECTRICAL SAFETY AUDIT OF RAM LAL ANAND COLLEGE- DELHI UNIVERSITY SOUTH CAMPUS

Conducted By: EM Project Services

Principal Auditor: Satvinder Singh

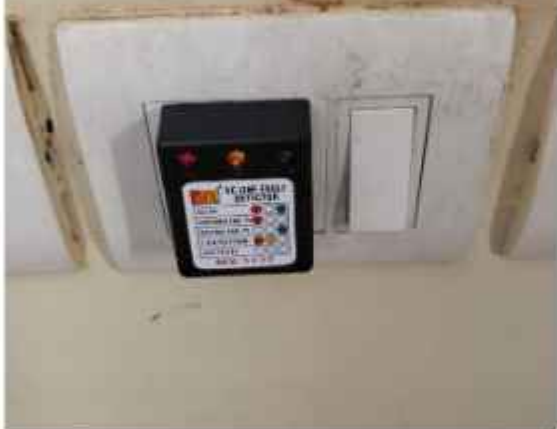
13

Reversed polarity-Neutral is controlled through switch instead of phase.	CPWD testing guidelines	All Sockets be got corrected for earth connection
14

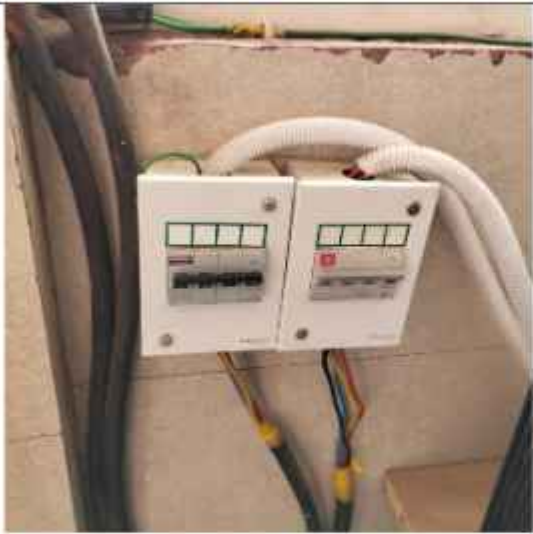
36

UPS supply MCB Box no earthing	IS-3043	Earth should be provided immediately
37

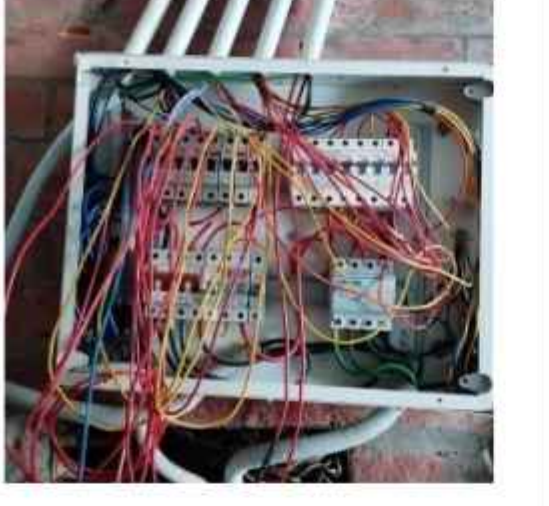
Wiring work going on in MCB DB near old Auditorium-Not proper	CPWD specifications/CEA guidelines-2010	During execution work also, all safety precautions should be taken

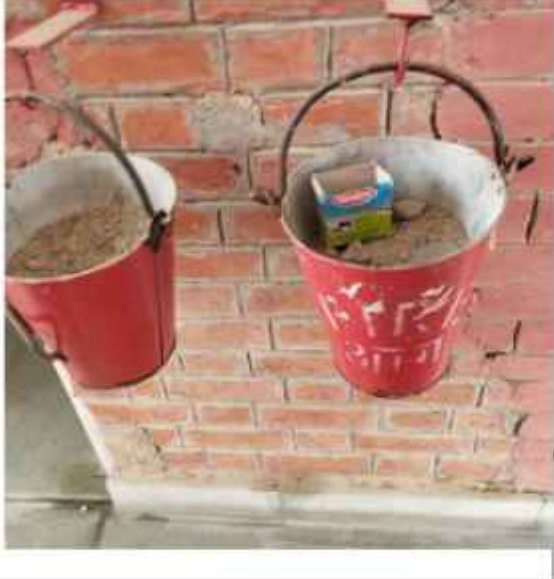
54

Sand buckets		
55

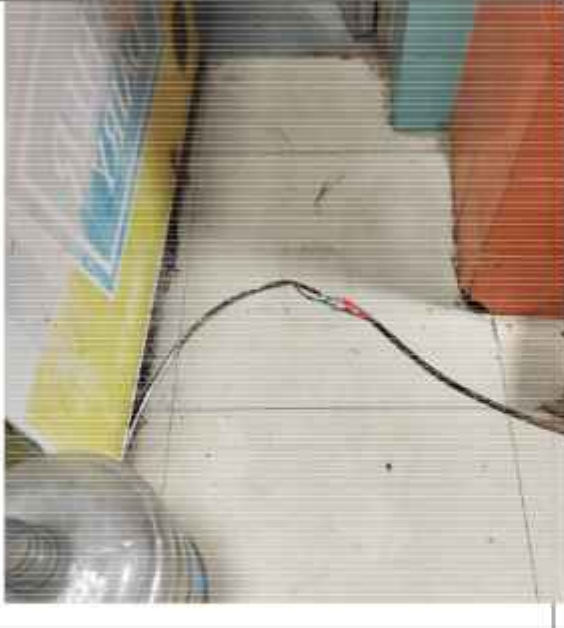
70

Wires laid on ground at canteen	CEA guidelines-2010/CPWD specifications	All electrical sockets should be fixed at wall for electrically safe condition
----	---	---------------------------------	---	--

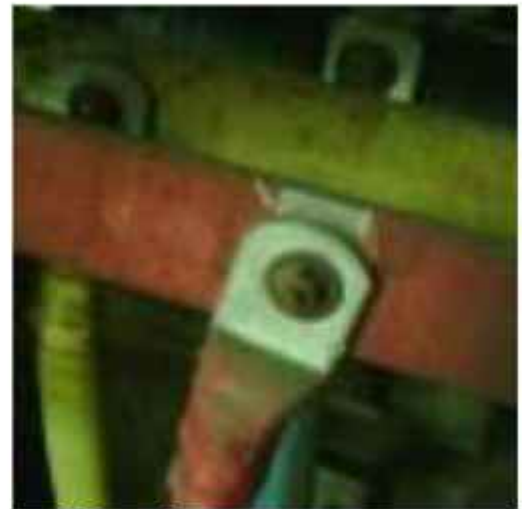
Main LT Panel bus bar

Name	Temperature	Emissivity	Background
Center point	50.2°C	0.95	20.0°C

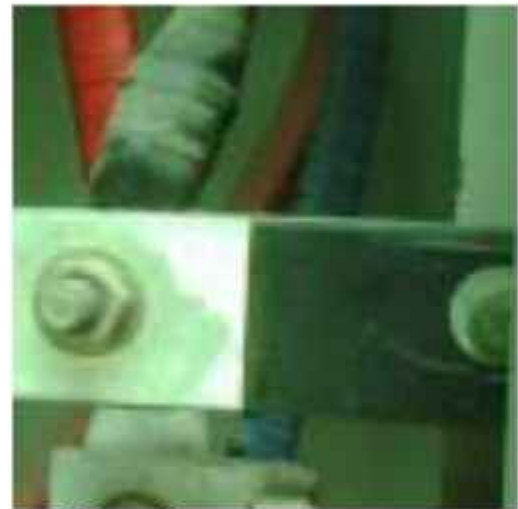
Location 400amp FPMCCB main
incoming power panel front
side

Name	Temperature	Emissivity	Background
Center point	46.3°C	0.95	20.0°C

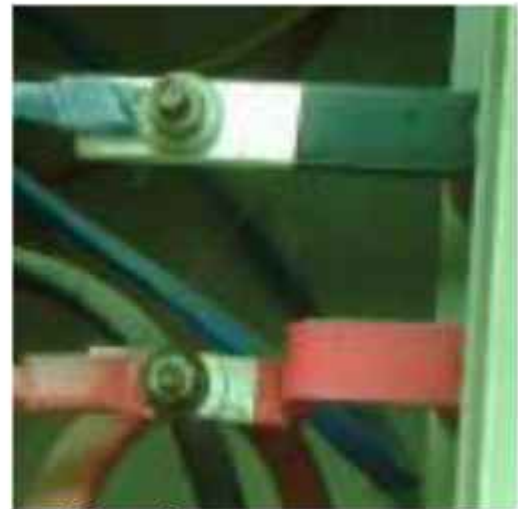
Location 250amp FPMCCB outgoing to MCB DB-2

Name	Temperature	Emissivity	Background
Center point	46.6°C	0.95	20.0°C

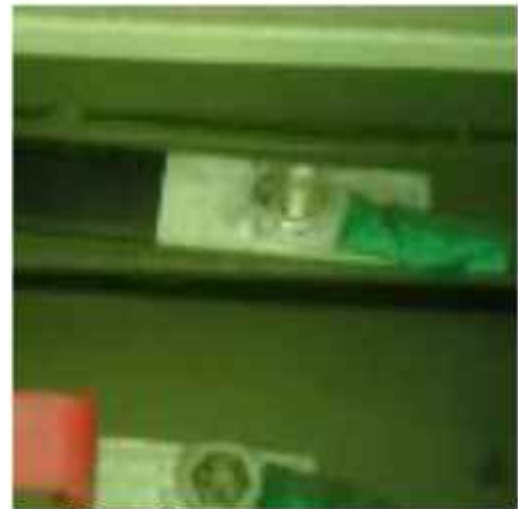
Location 250amp FPMCCB outgoing to
MCB DB-3

Name	Temperature	Emissivity	Background
Center point	53.5°C	0.95	20.0°C

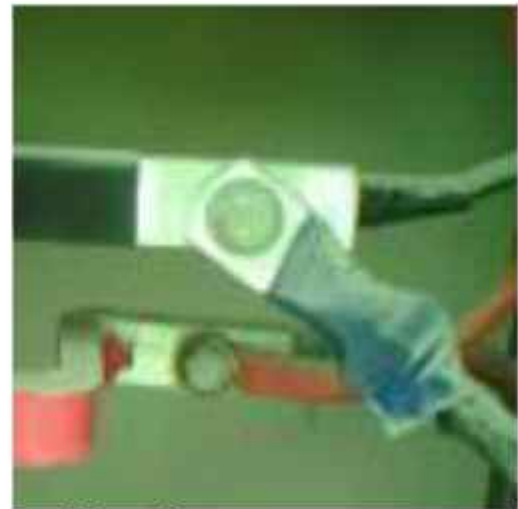
Location 250amp FPMCCB outgoing to MCB DB-4

Name	Temperature	Emissivity	Background
Center point	50.0°C	0.95	20.0°C

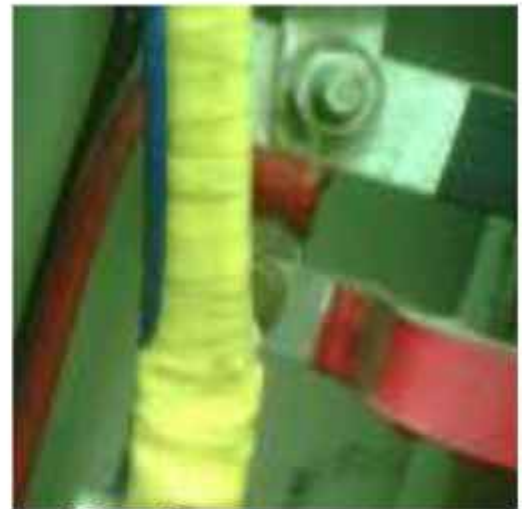
Location 250amp FPMCCB main
incoming light panel front
side

Name	Temperature	Emissivity	Background
Center point	48.4°C	0.95	20.0°C

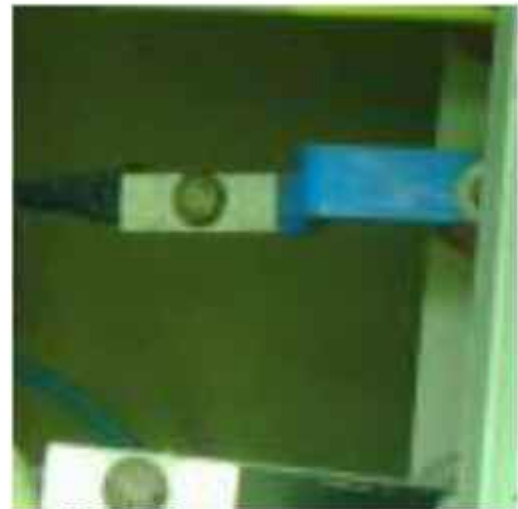
Location 250amp FPMCCB outgoing to
MCB DB-1

Name	Temperature	Emissivity	Background
Center point	48.6°C	0.95	20.0°C

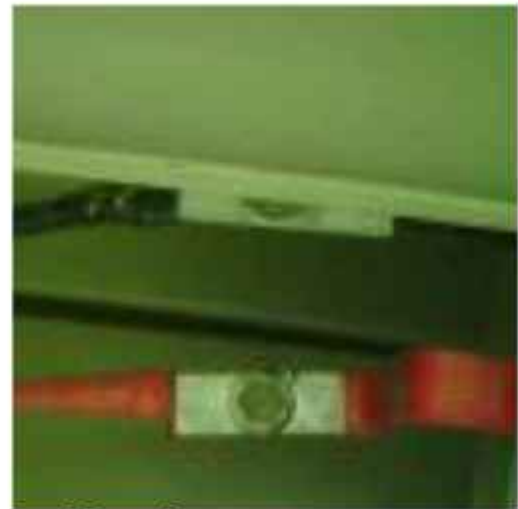
Location 250amp FPMCCB outgoing to
MCB DB-2

Name	Temperature	Emissivity	Background
Center point	53.7°C	0.95	20.0°C

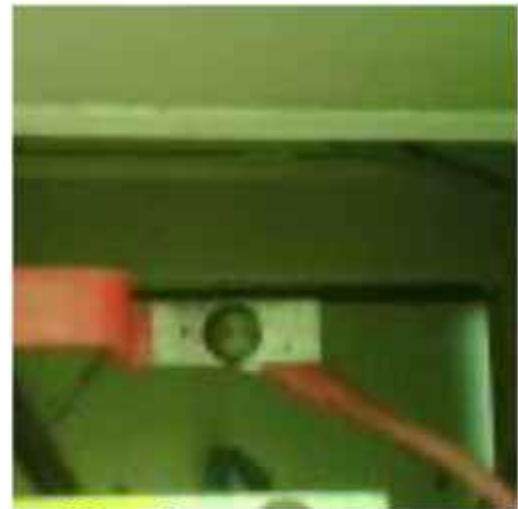
Location 250amp FPMCCB outgoing to MCB DB-3

Name	Temperature	Emissivity	Background
Center point	54.6°C	0.95	20.0°C

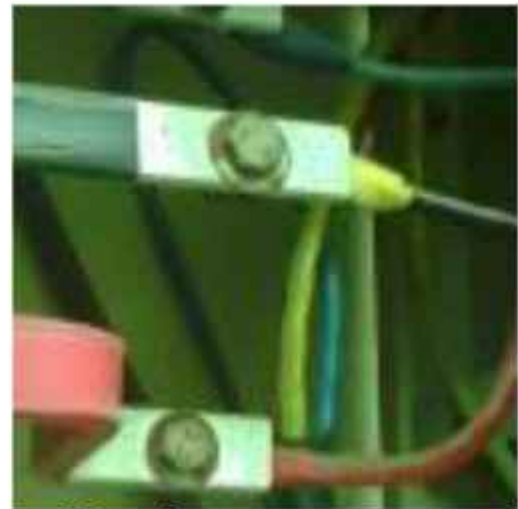
Location 250amp FPMCCB outgoing to MCB DB-4

Name	Temperature	Emissivity	Background
Center point	48.0°C	0.95	20.0°C

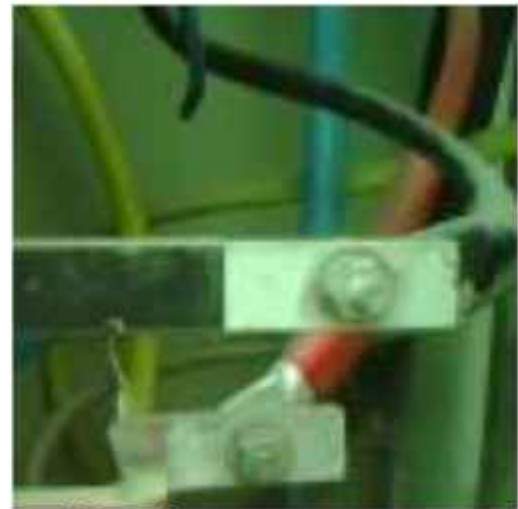
Location 250amp FPMCCB outgoing to MCB DB-6

Name	Temperature	Emissivity	Background
Center point	46.7°C	0.95	20.0°C

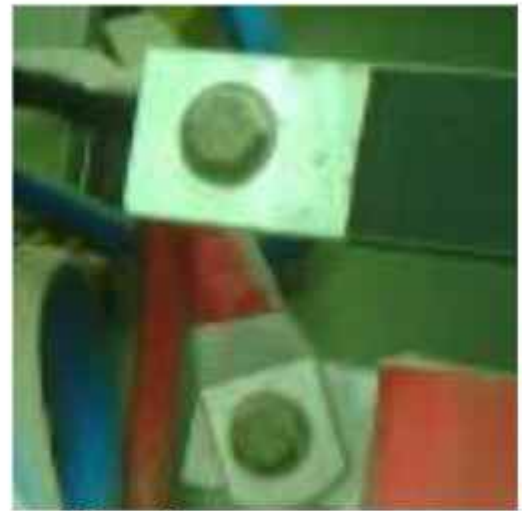
Location 400amp FPMCCB main
incoming power panel rear
side

Name	Temperature	Emissivity	Background
Center point	44.1°C	0.95	20.0°C

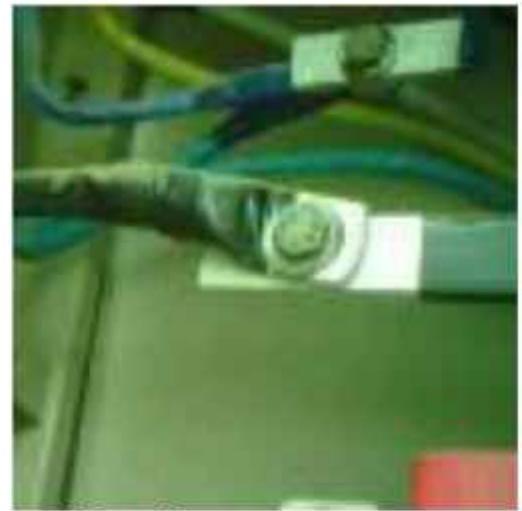
Location 250amp FPMCCB outgoing to
MCB DB-1

Name	Temperature	Emissivity	Background
Center point	41.5°C	0.95	20.0°C

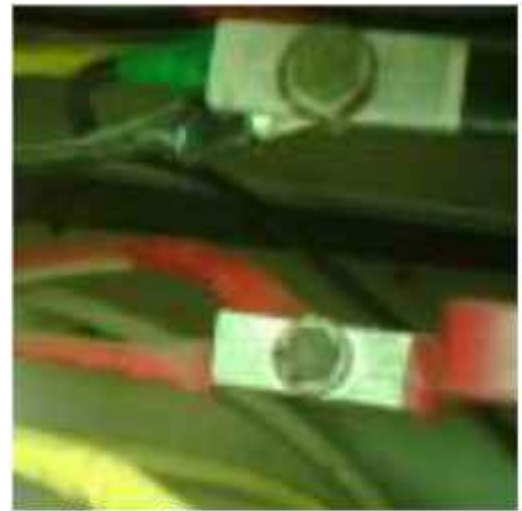
Location 250amp FPMCCB outgoing to
MCB DB-2

Name	Temperature	Emissivity	Background
Center point	42.3°C	0.95	20.0°C

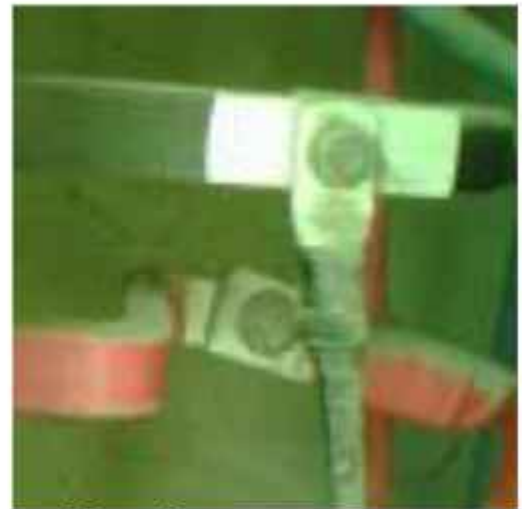
Location 250amp FPMCCB outgoing to
MCB DB-Library Power

Name	Temperature	Emissivity	Background
Center point	43.9°C	0.95	20.0°C

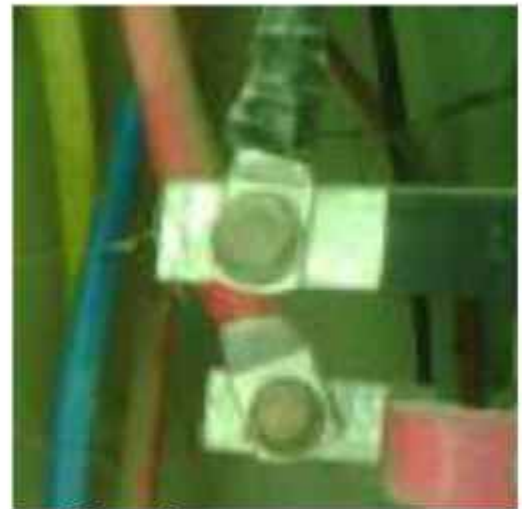
Location 250amp FPMCCB main
incoming light panel rear side

Name	Temperature	Emissivity	Background
Center point	43.4°C	0.95	20.0°C

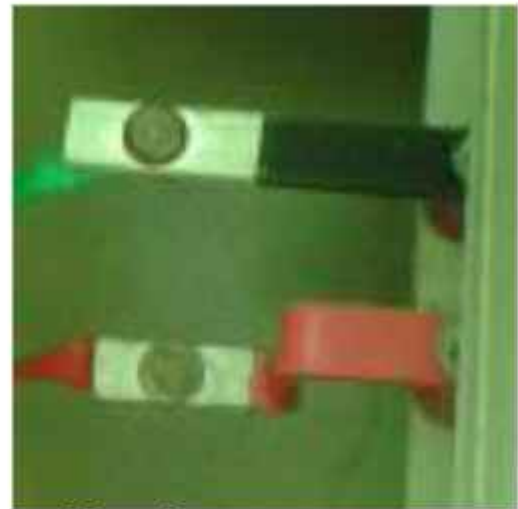
Location 250amp FPMCCB outgoing to
MCB DB-1

Name	Temperature	Emissivity	Background
Center point	41.3°C	0.95	20.0°C

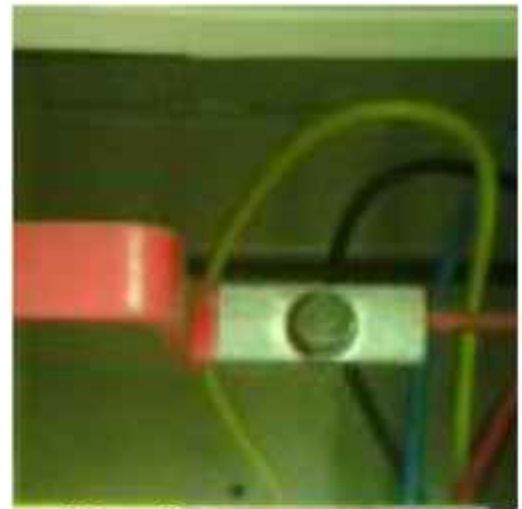
Location 250amp FPMCCB outgoing to
MCB DB-2

Name	Temperature	Emissivity	Background
Center point	41.8°C	0.95	20.0°C

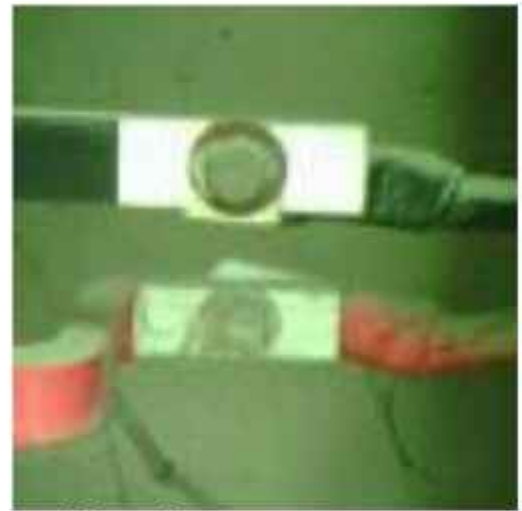
Location 250amp FPMCCB outgoing to
MCB DB-Library Lighting

Name	Temperature	Emissivity	Background
Center point	42.1°C	0.95	20.0°C

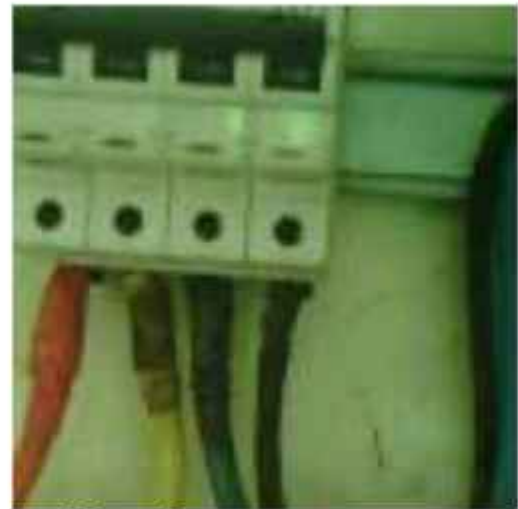
Name	Temperature	Emissivity	Background
Center point	41.3°C	0.95	20.0°C

Loose connection-Y Phase

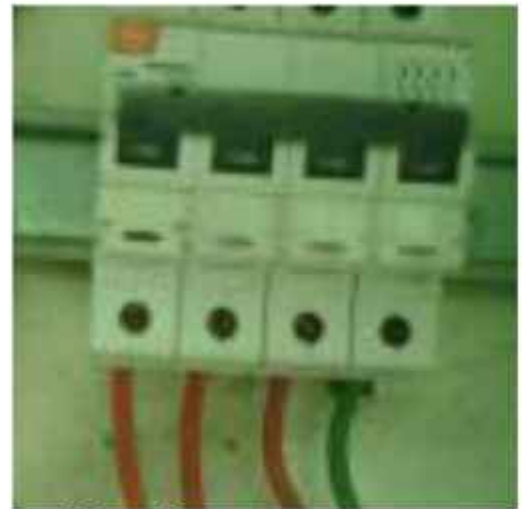
Name	Temperature	Emissivity	Background
Center point	60.0°C	0.95	20.0°C

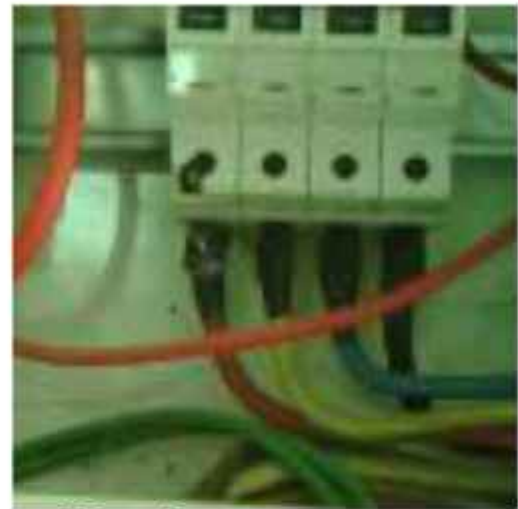
Name	Temperature	Emissivity	Background
Center point	37.6°C	0.95	20.0°C

Loose connection-Y Phase

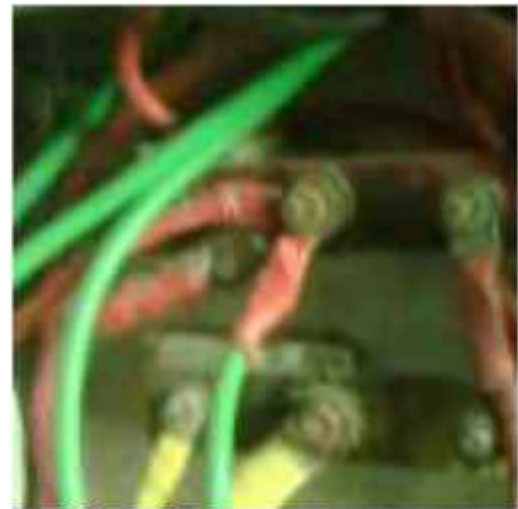
Name	Temperature	Emissivity	Background
Center point	47.3°C	0.95	20.0°C

Loose connection-Y Phase

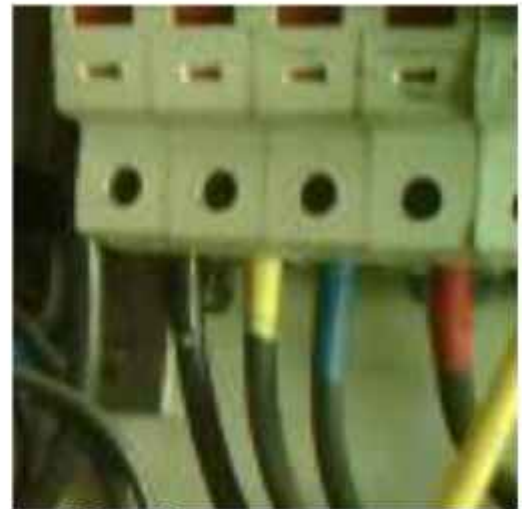
Name	Temperature	Emissivity	Background
Center point	37.3°C	0.95	20.0°C

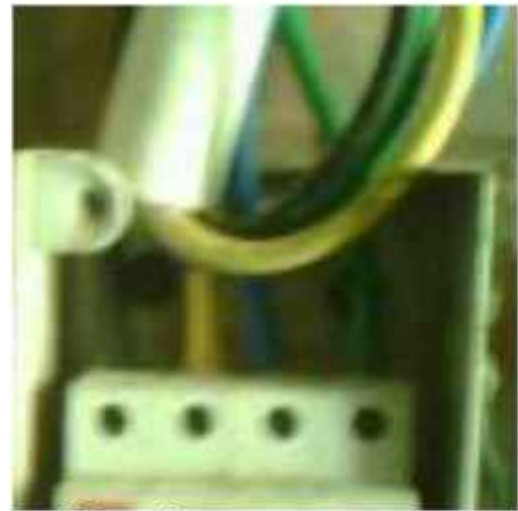
Name	Temperature	Emissivity	Background
Center point	38.4°C	0.95	20.0°C

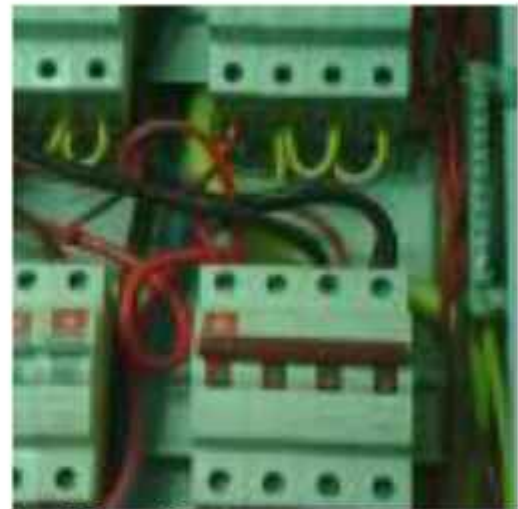
Name	Temperature	Emissivity	Background
Center point	36.7°C	0.95	20.0°C

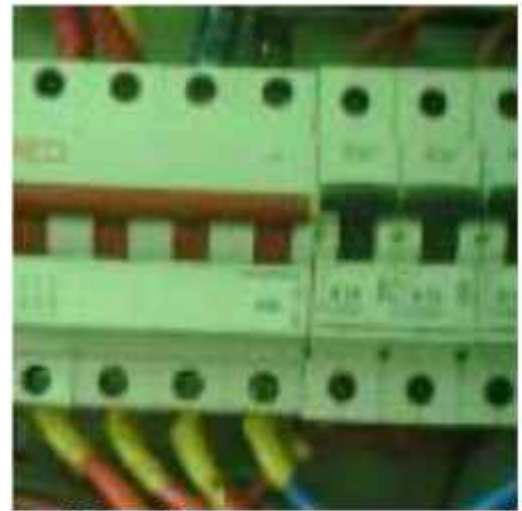
Location

Name	Temperature	Emissivity	Background
Center point	40.2°C	0.95	20.0°C

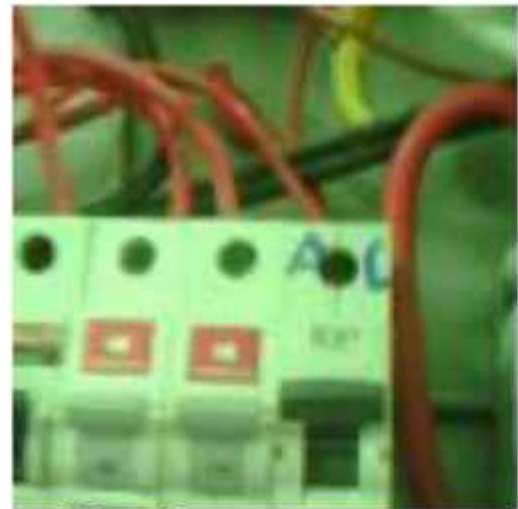
Location 63amp FPMCB main
incoming in DB-computer lab

Name	Temperature	Emissivity	Background
Center point	38.4°C	0.95	20.0°C

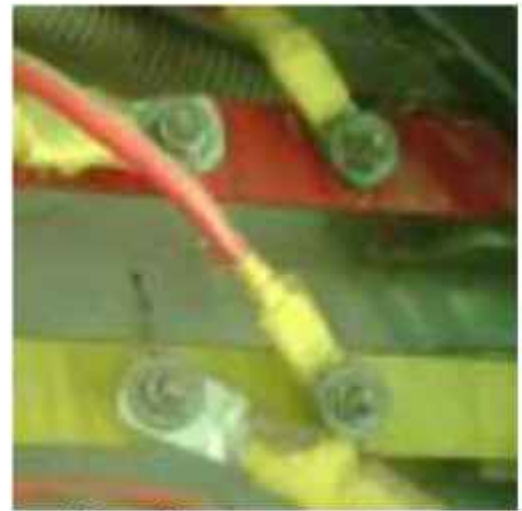
Location 100amp bus bar main
incoming outside computer
lab

Name	Temperature	Emissivity	Background
Center point	38.8°C	0.95	20.0°C

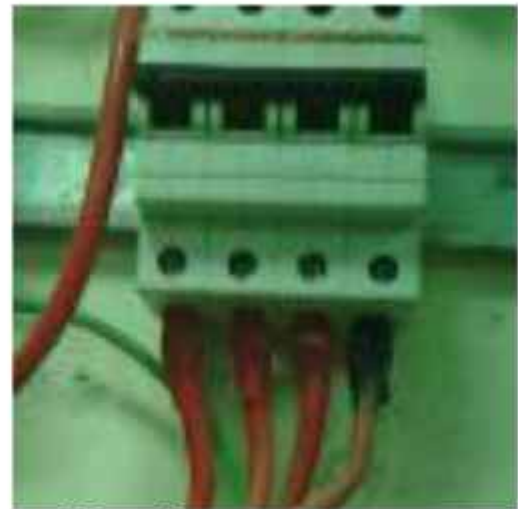
Location 63amp FPMCB main
incoming in DB-4 library

Name	Temperature	Emissivity	Background
Center point	36.2°C	0.95	20.0°C

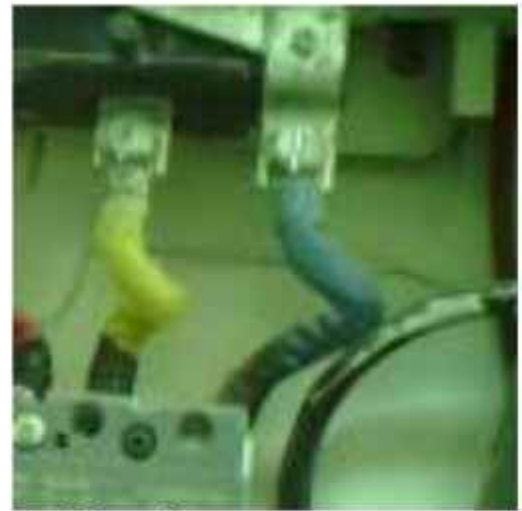
Location 100amp FPMCCB main
incoming in Light DB-library

Name	Temperature	Emissivity	Background
Center point	35.1°C	0.95	20.0°C

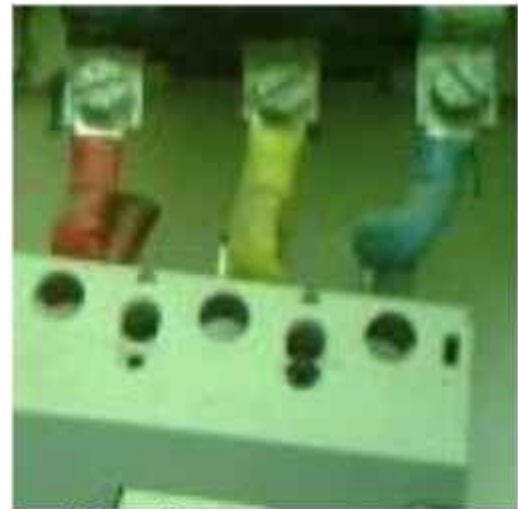
Location 200amp FPMCCB main
incoming in power DB-library

Name	Temperature	Emissivity	Background
Center point	36.4°C	0.95	20.0°C

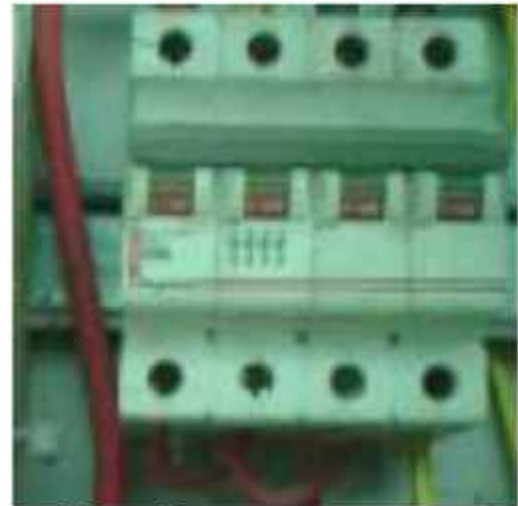
Location

Name	Temperature	Emissivity	Background
Center point	36.6°C	0.95	20.0°C

Observation
Internal heating
observed

Inference
Isolator needs
replacement

Recommendation
It should be replaced

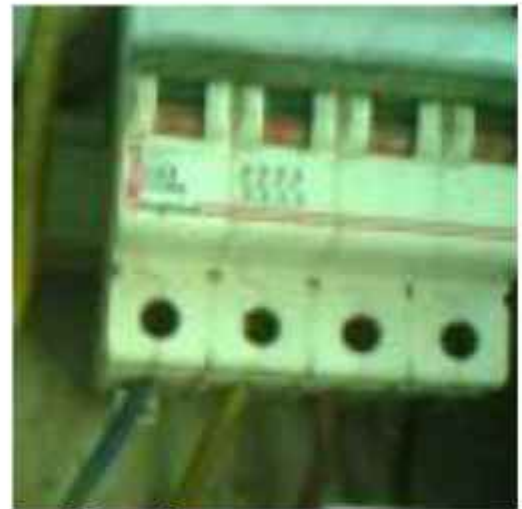
Location

Name	Temperature	Emissivity	Background
Center point	47.9°C	0.95	20.0°C

Observation
Internal heating
observed

Inference
Isolator needs
replacement

Recommendation
It should be replaced

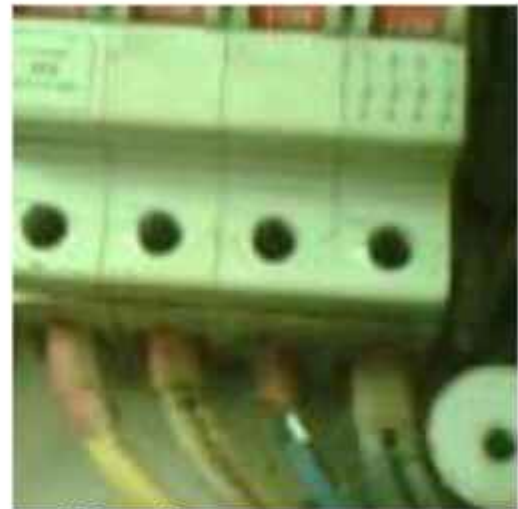
Location

Name	Temperature	Emissivity	Background
Center point	49.1°C	0.95	20.0°C

Observation
Internal heating
observed

Inference
Isolator needs
replacement

Recommendation
It should be replaced

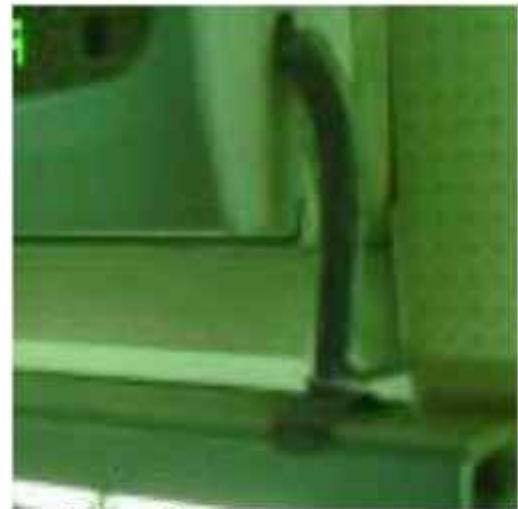
Location AC-1-Windowtype Computer Science Lab

Name	Temperature	Emissivity	Background
Center point	36.6°C	0.95	20.0°C

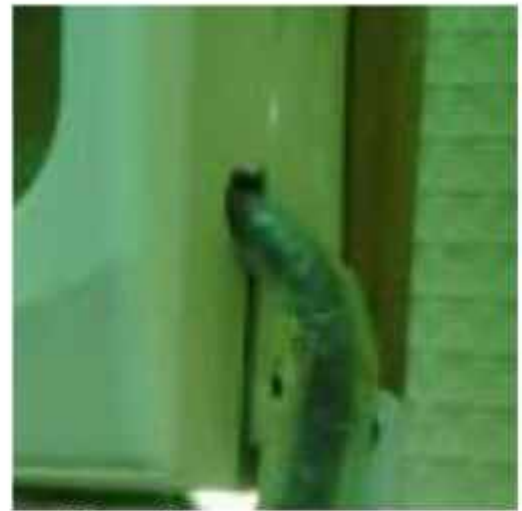
Location AC-2-Window Computer Science Lab

Name	Temperature	Emissivity	Background
Center point	41.3°C	0.95	20.0°C

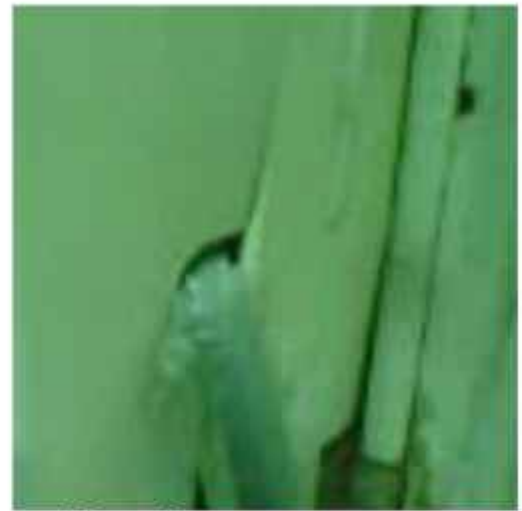
Name	Temperature	Emissivity	Background
Center point	40.3°C	0.95	20.0°C

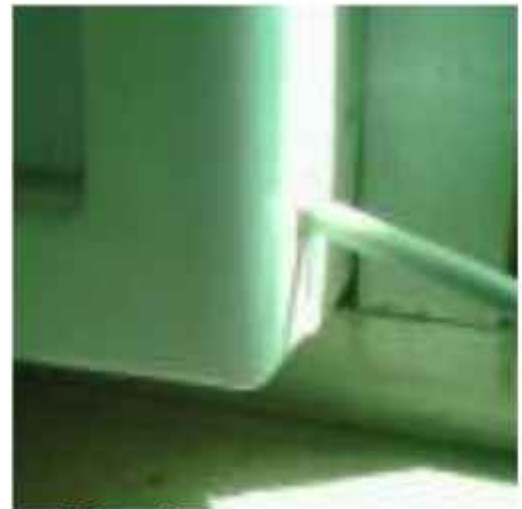
Name	Temperature	Emissivity	Background
Center point	40.1°C	0.95	20.0°C

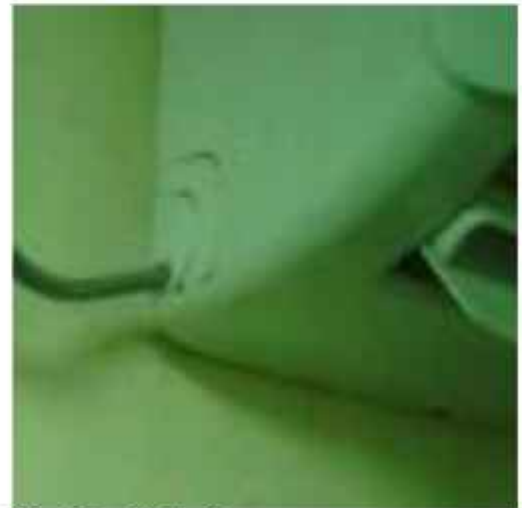
Name	Temperature	Emissivity	Background
Center point	36.5°C	0.95	20.0°C

Higher temperature observed.-Connections be got tightened
